5-Year Master Plan

MONROE COUNTY
COMMUNITY COLLEGE

MONROE COUNTY COMMUNITY COLLEGE
FACILITIES ASSESSMENT AND DEFERRED MAINTENANCE
CAPITAL PLANNING REPORT
2008 UPDATE

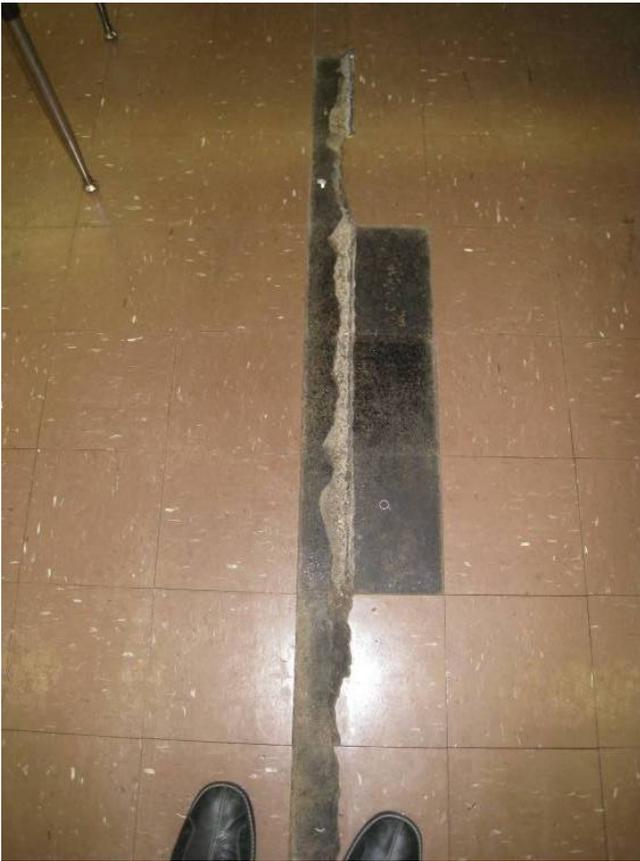
West Technology – concrete slab movement has telegraphed through the floor tile resulting in a failed section of flooring.

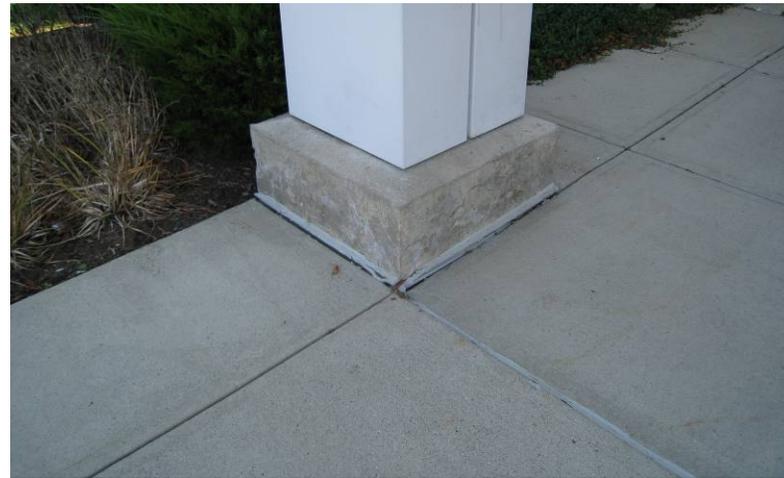
Health Education Building – settlement in exterior slabs may result in a tripping hazard and should be monitored.

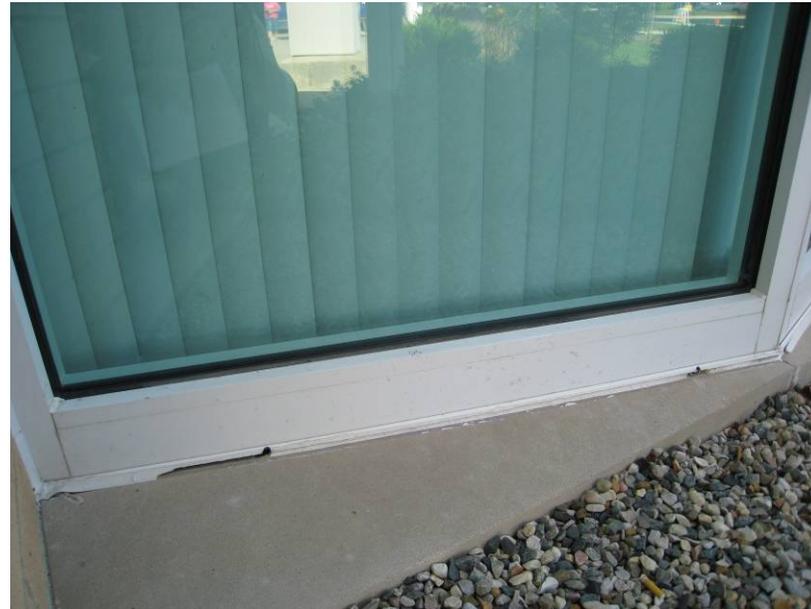
Health Education Building – Ongoing water infiltration problems with the aluminum window framing should be monitored.

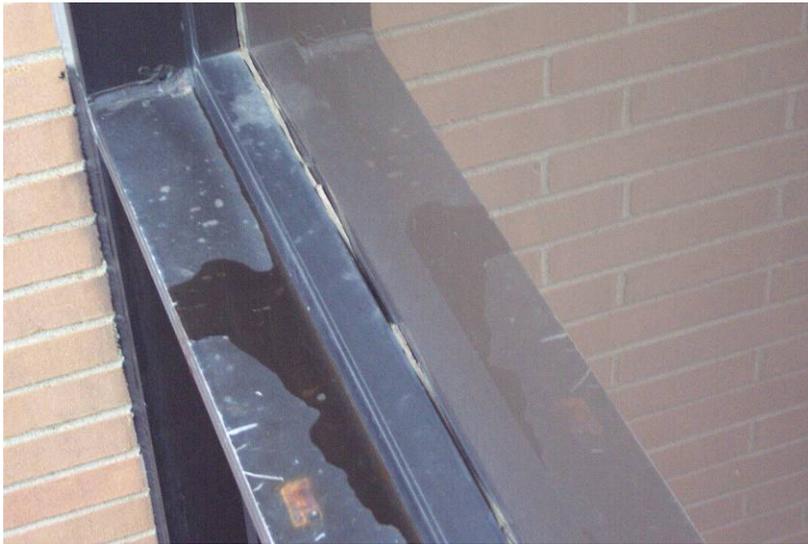
Life Sciences Building – failing original sealant allowing water infiltration, causing damage to interior finishes.

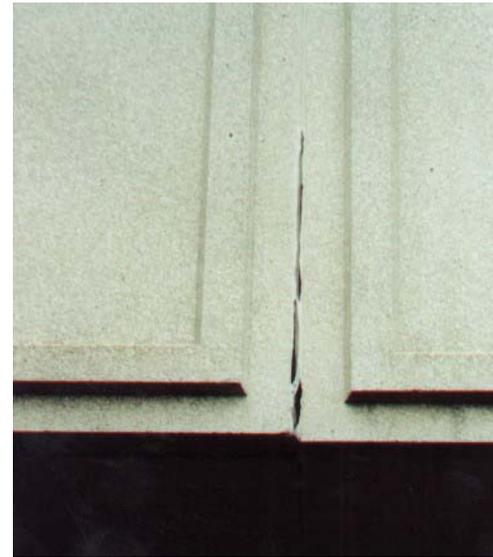
Technology Building - Precast concrete fascia panels separating from excessive movement

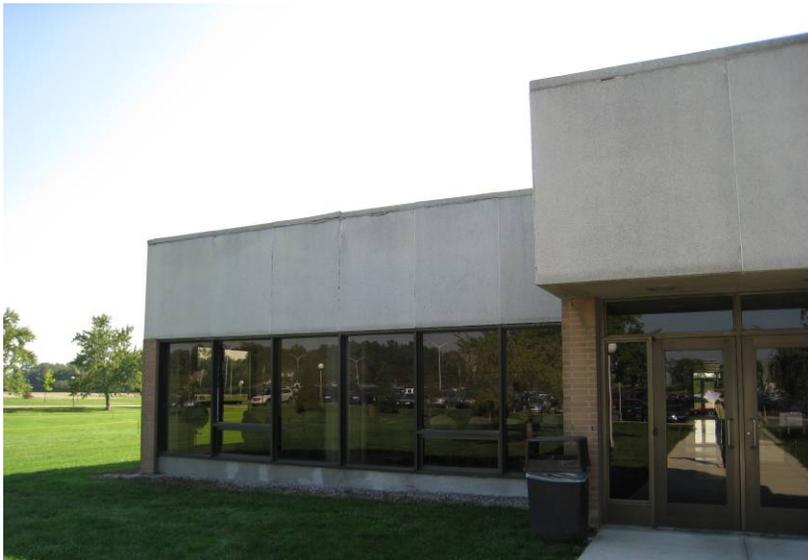
Life Sciences Building – concrete composite parapet caps loose, cupping and deteriorating.

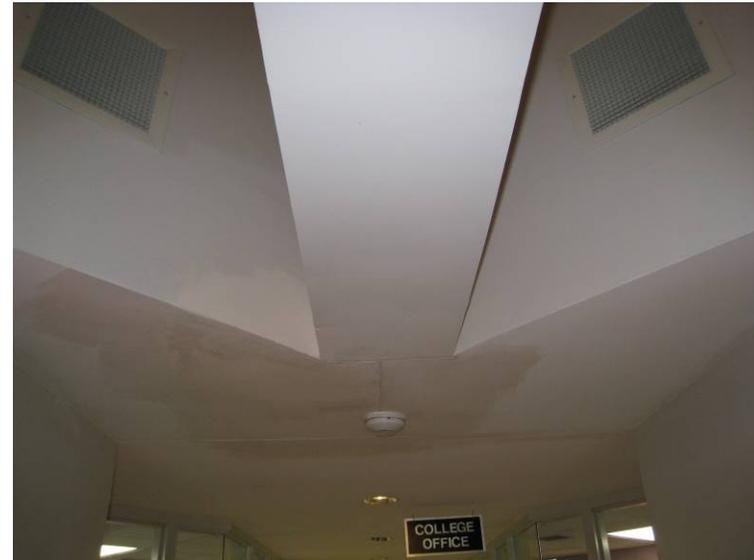
Whitman Center – College is completing repairs to ceiling damage and has installed movement joints in an effort to limit future cracking. The lack of movement joints is causing cracking elsewhere in the facility.
