Building Report | Life Sciences Façade & Addition

7.7.17

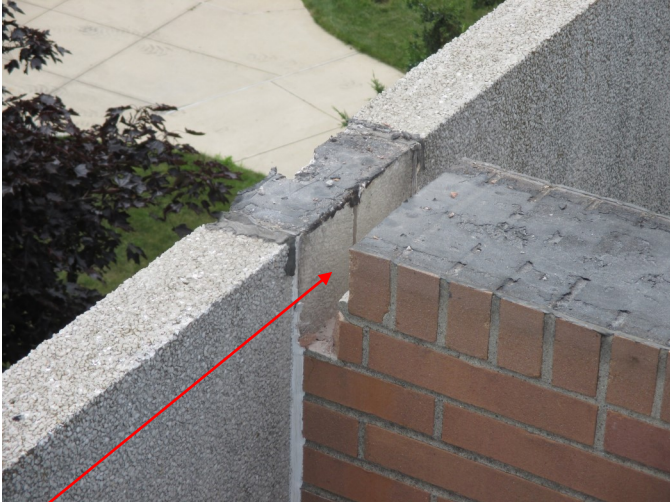
The top-left photo shows some of the investigative work into the connections of the sun shades at the top of the ribs on the southwest corner of the Life Sciences Building. The metal coping has been removed and you can see of the panels are "floating" in place.

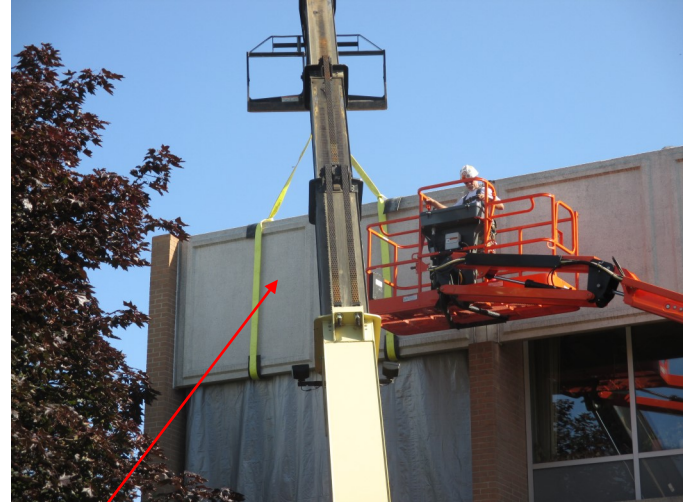
The top-right photo shows the progress in the process to remove the panels. The demolition of the sun shades is an extremely labor intensive process and one that will have to be done with extreme caution so as not to damage the surrounding building.

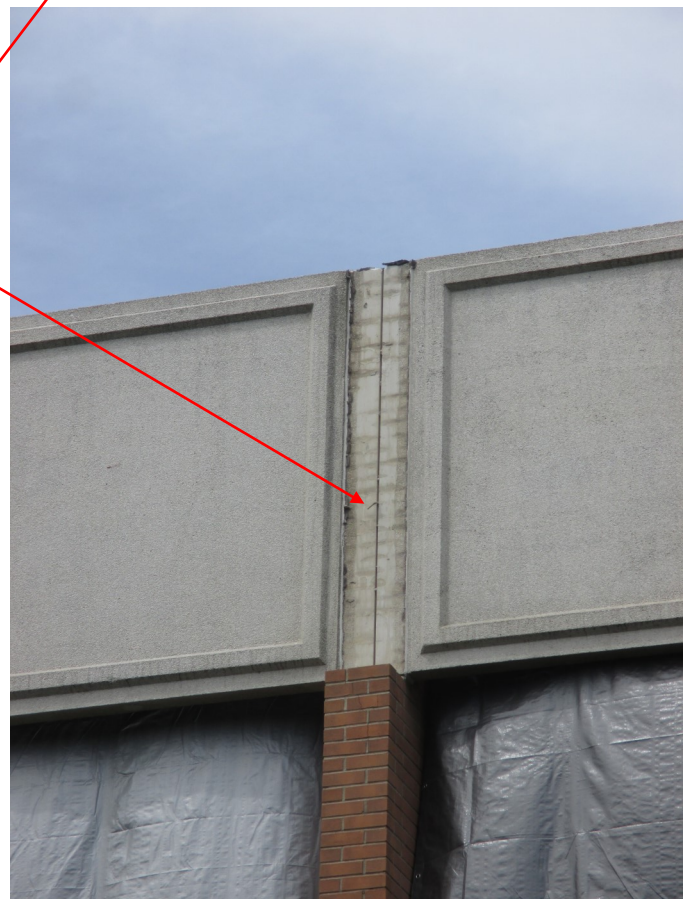
The bottom-right photo shows the joints of the panels with the face brick removed. As suspected there were no metal ties connecting the brick with the panels.
