# Building Report | Life Sciences Façade & Addition

10.13.17

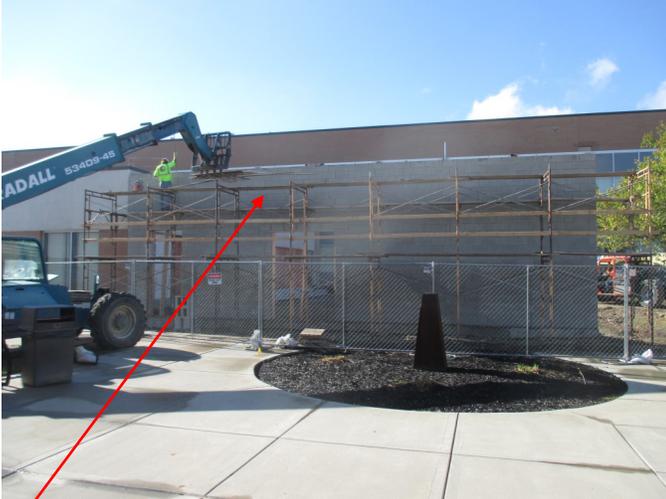
The top-left photo highlights the progress of the construction of the cmu wall that forms the north side of the new addition. This wall will be clad in metal panels on the exterior similar to those on the CTC.

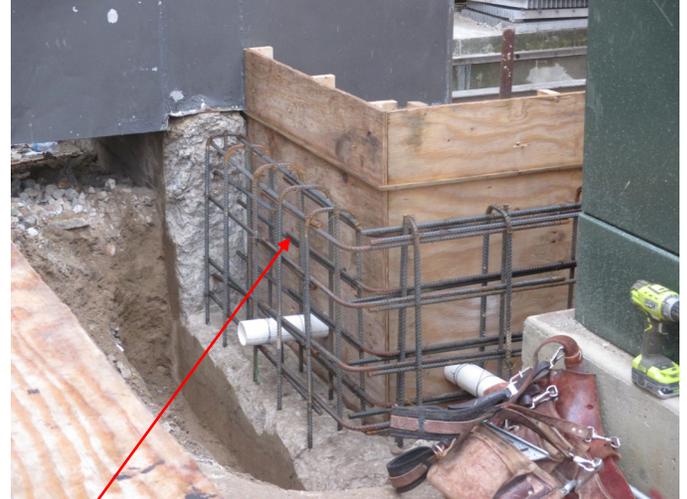
The top-right photo shows the progress of the corrective work being done on the mechanical well on the northeast corner of the building. The failing portions of the wall have been removed and new reinforcing steel is placed and the formwork is being constructed so that the new concrete can be placed.

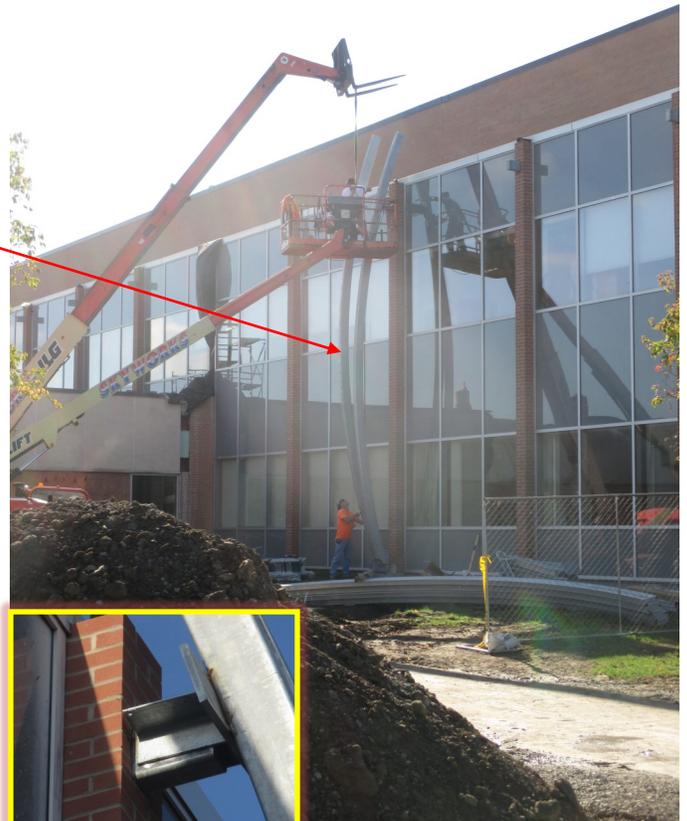
The bottom-left photo shows more progress of the curved steel support frames. The enlarged photo at the bottom shows how the curved metal frames are attached at the base.

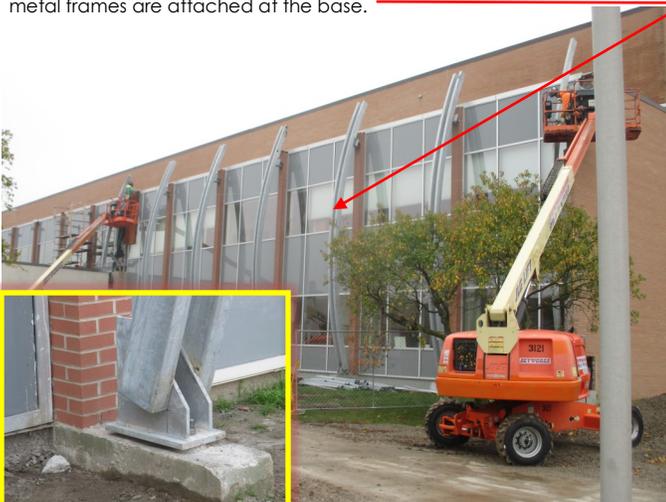
The bottom-right photo shows the progress of the new curved steel support frames on the north side of the building. Once completed the new horizontal bands of meshed metal panels will be installed. The enlarged photo in the corner shows how they are connected at the top to metal arms that attached to the existing building structural frame.
