# Building Report | Life Sciences Façade & Addition

10.20.17

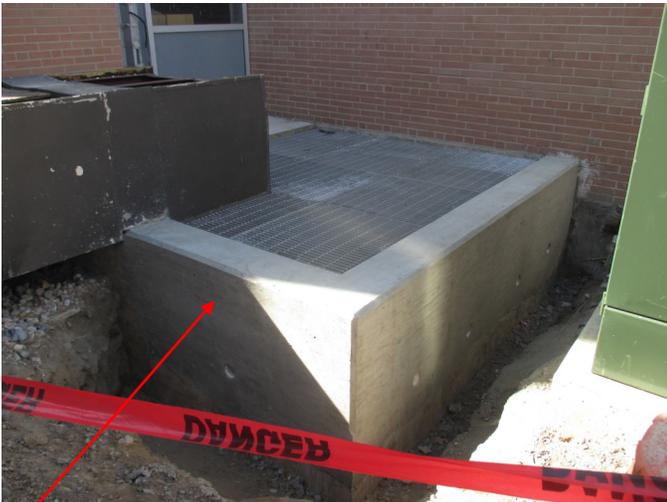
The top-left photo shows the now completed repairs to the mechanical area well concrete walls. The forms have been stripped and the metal grates have been set back in place.

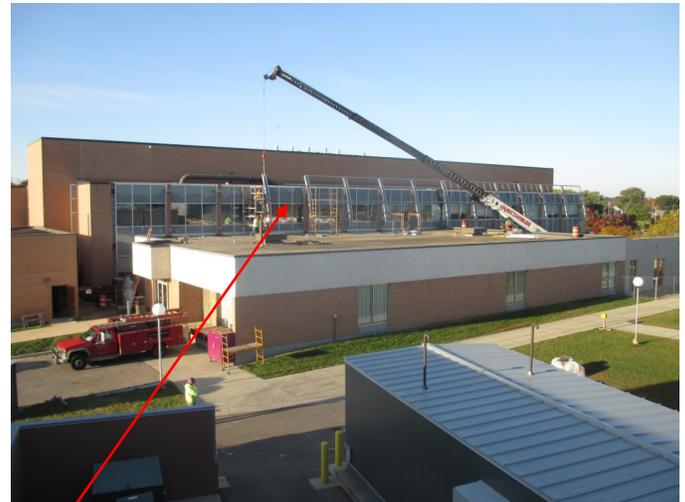
The top-right photo gives a good glimpse of the overall progress of the installation of the support steel being erected on the north face of the building for the new shade system. Only a few bays are left to receive steel, and then in a few weeks the mesh panels will be installed.

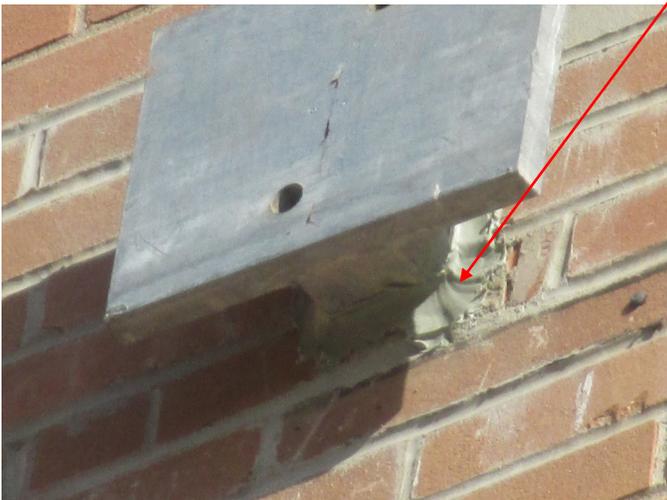
The bottom-left photo is enlarged detail showing some of the sealant work that was installed this week around the steel supports as they penetrate the brick veneer.

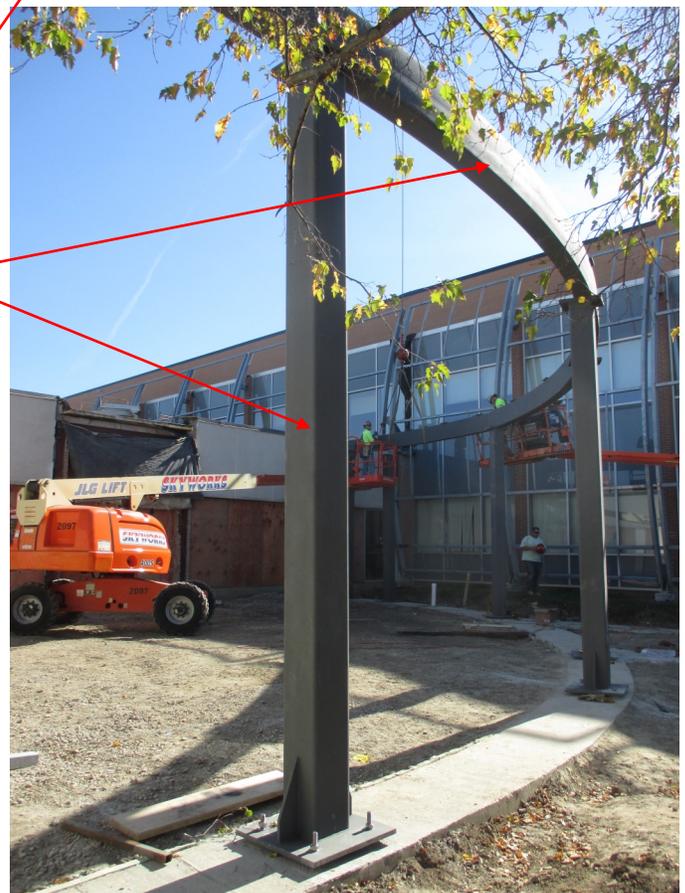
The bottom-right photo shows the first pieces of structural steel for the building addition being erected. Here you can see some of the tube steel columns and beams that will support the roof over the curved curtain wall that comprises the west wall of the addition. Next week the open-web bar joists for the roof will be set into place.
