Building Report | Life Sciences Façade & Addition

10.6.17

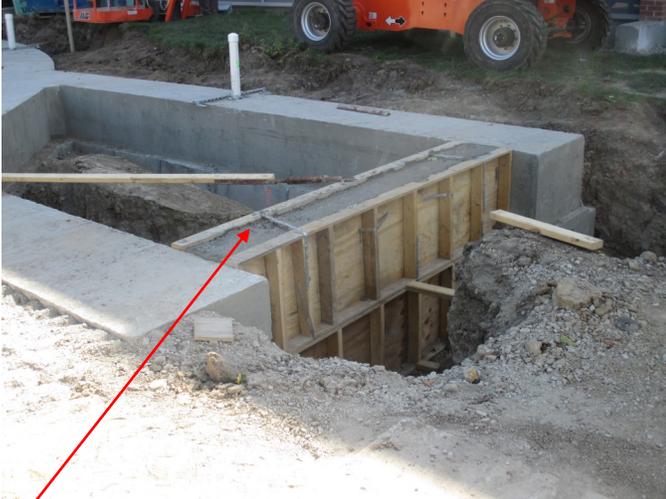
The top-left photo shows another portion of the foundation system being completed. Here the part of the foundation that forms the frost-proof stoop for the new addition entry has been formed and the concrete placed.

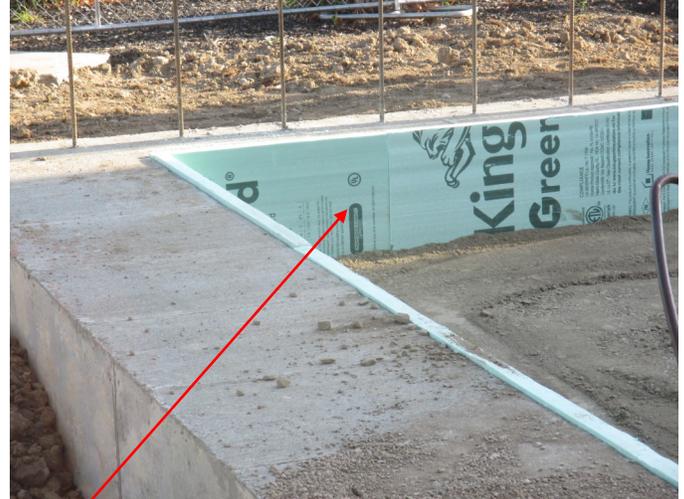
The top-right photo is a close-up highlighting the installation of the rigid insulation board around the perimeter of the foundation.

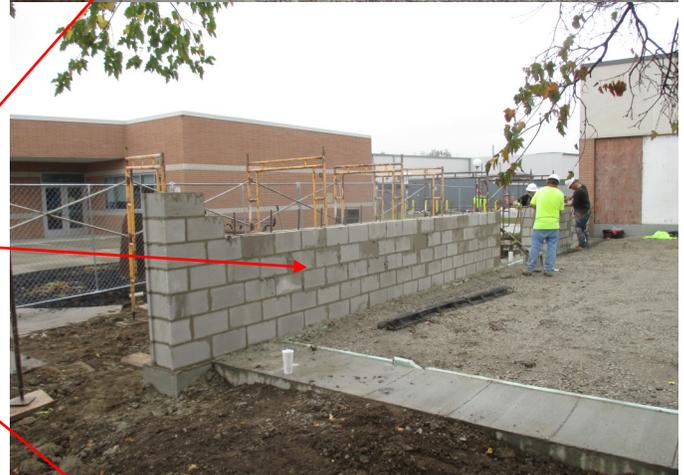
The middle-right photo shows the masons beginning installing the concrete block portion of the north wall of the addition.

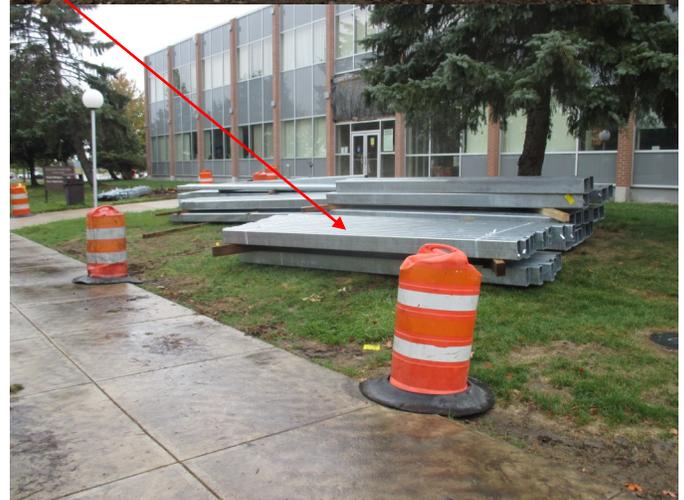
The bottom-right photo shows the one of many stockpiles of steel that was delivered this week and will form the backer system for the sunshades on the south side of the building. This steel will start to be installed next week.

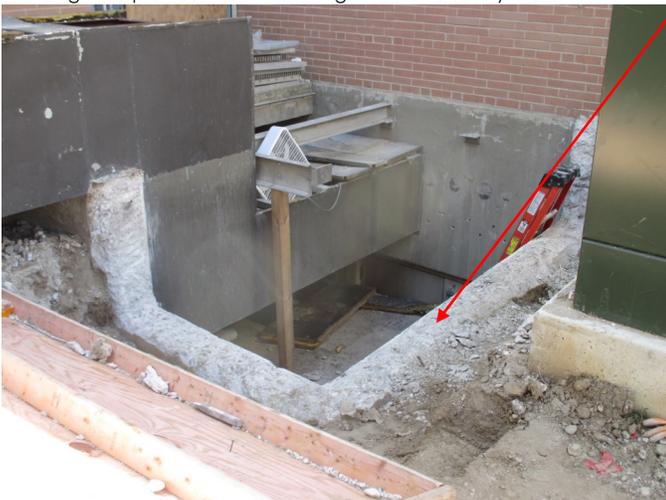
The bottom-left photo shows the beginning of the process to repair the concrete walls of the mechanical pit at the northeast corner of the building. The previous wall was failing and was a safety issue.
