Building Report | Life Sciences Façade & Addition

12.1.17

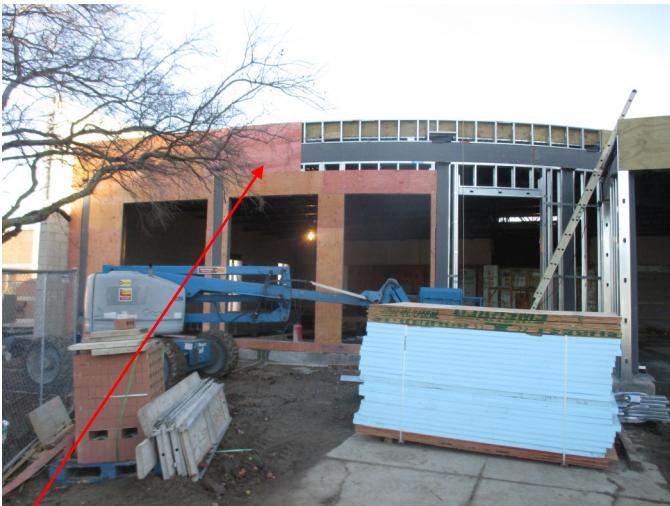
The top-left photo shows the progress of the installation of the plywood sheathing on the exterior side of the curved west wall of the addition. Once the sheathing is finished and covered with a vapor barrier the brick veneer can be installed.

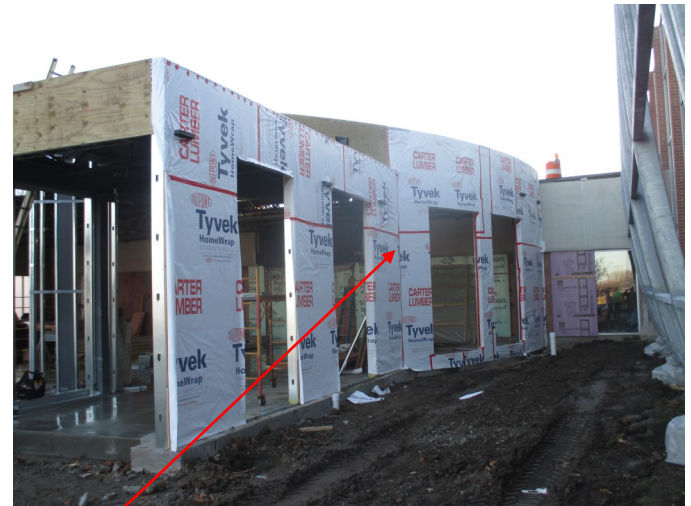
The top-right photo shows the installation of the vapor barrier over the exterior sheathing on the south side of the addition.

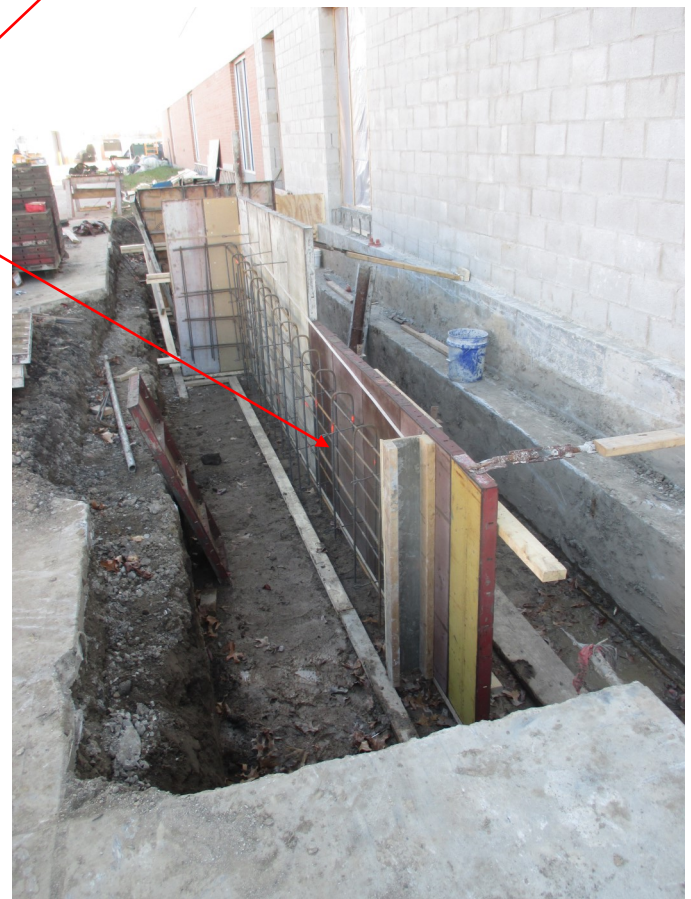
The bottom-right photo highlights the progress of the forming of the exterior ramp and stairs on the north side of the addition. Here you can see some of the reinforcing steel in place before the form is completed. The concrete for the ramp and stairs will be placed next week.

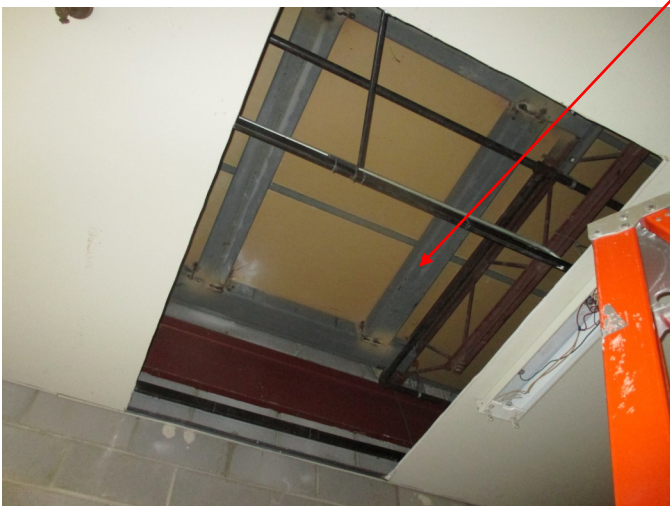
The bottom-left photo shows the installation of the support steel for the new roof access hatch for the roof over the north wing of the existing building. Previously this roof was only accessible by ladder, however when the access hatch is finished the maintenance staff will be able to gain access to the roof without the need for a ladder.
