Building Report | Life Sciences Façade & Addition

8.18.17

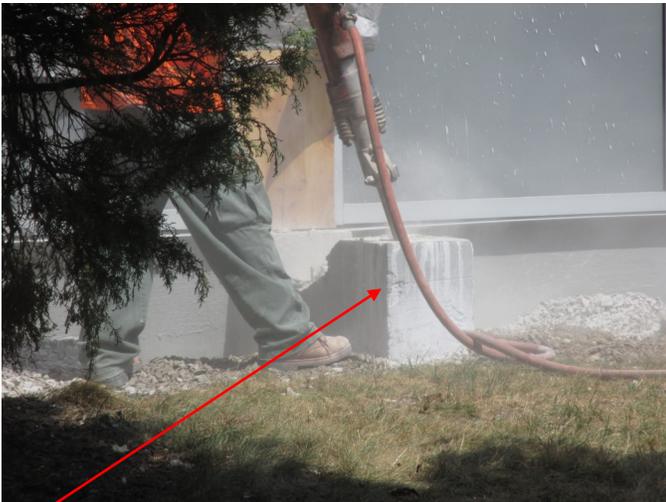
The top-left photo illustrates the work needed to cut back the old brick pier foundations as part of this project. The piers will only project 4" from the face of the building now, so that they can support the new brick veneer being installed soon.

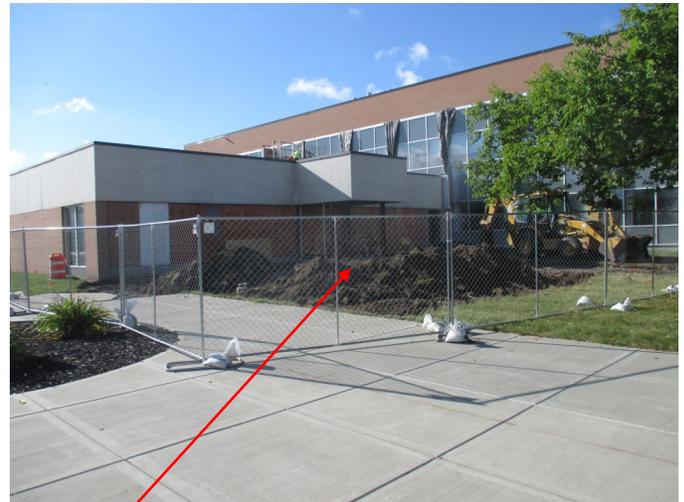
The top-right photo shows the start of the excavation of the footings and foundation of the addition on the northwest side of the building. This work will finish next week and then the contractor will place the necessary forms so concrete can be poured in place.

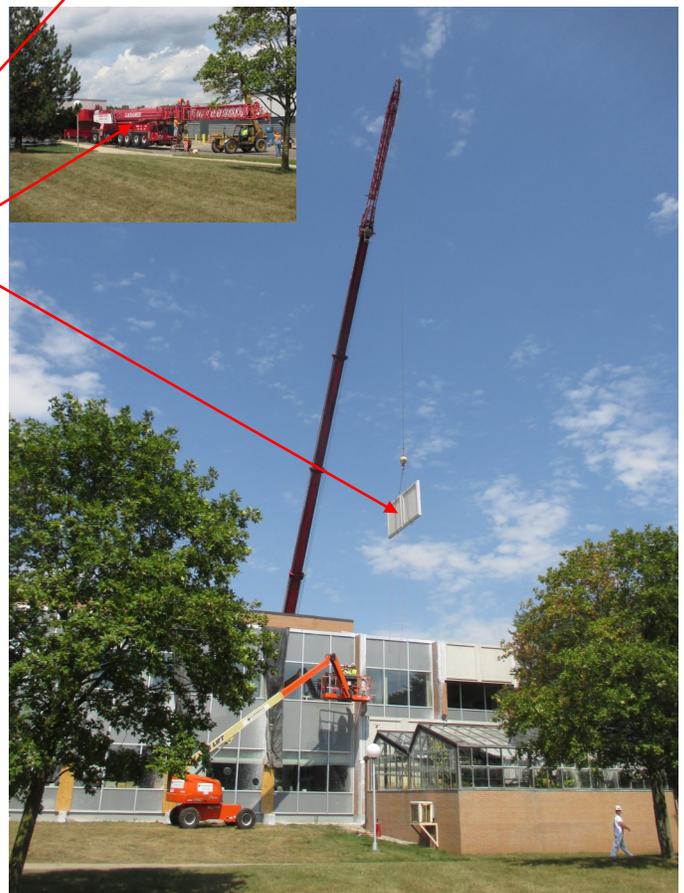
The bottom-right photos highlight the large crane necessary and the process in removing one of the last concrete sunshade panels from the south face of the building near the greenhouse.

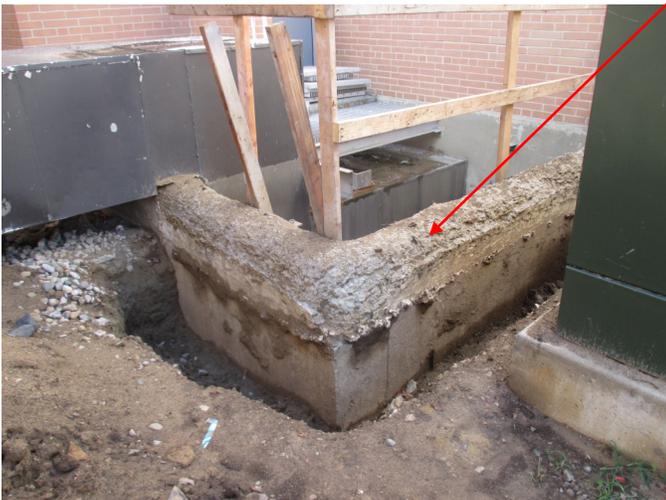
The bottom-left photo shows the mechanical area well on the northeast side of the building and the start of the much needed corrective work as part of this project. Here the first feet of crumbling concrete wall will be removed and replaced to properly support the metal grating.
