Building Report | Life Sciences Façade & Addition

9.1.17

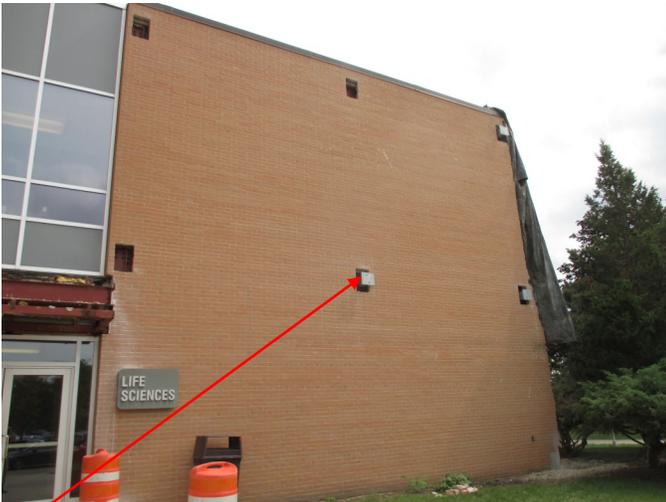
The top-left photo highlights the work being done on the south-west façade of the building. Here steel connectors are being welded to the building frame so the new metal screen veneer can be attached in front of the existing brick.

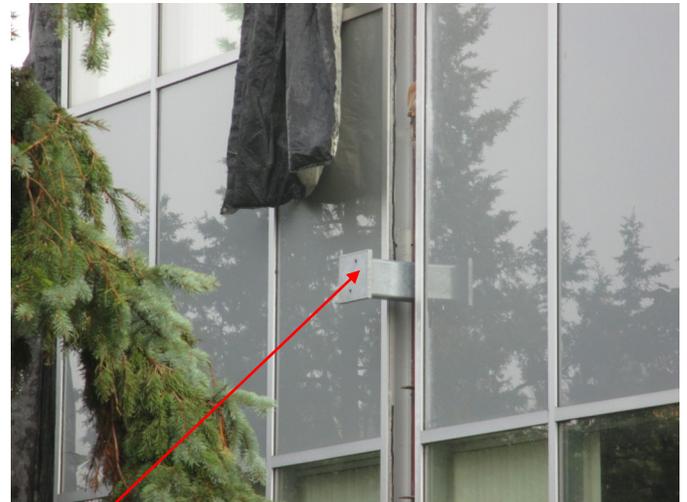
The top-right photo is a close up of one of the new steel connectors which is located on the south face of the building.

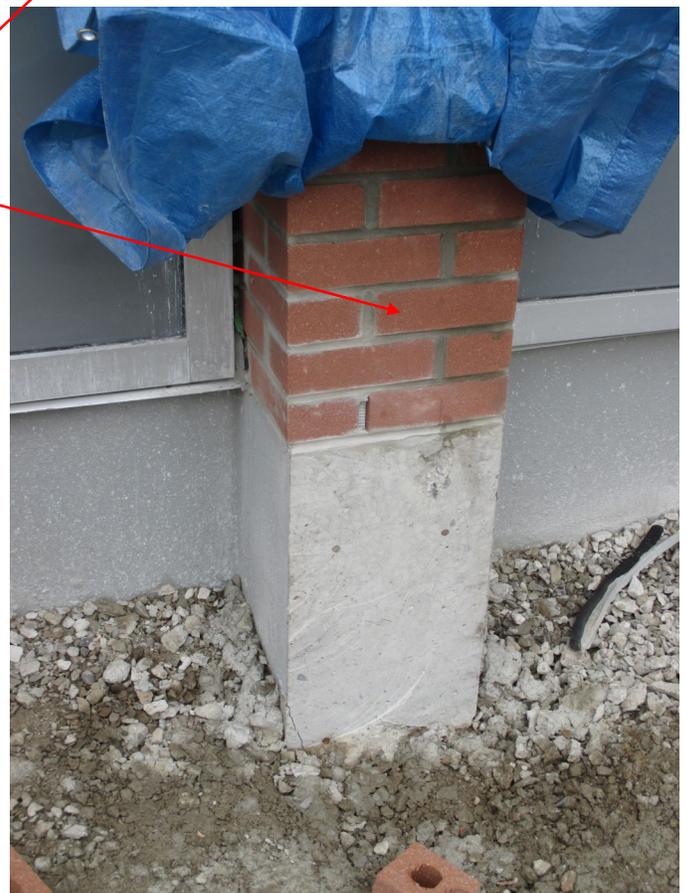
The bottom-right photo is a test installation of the new brick ribs that will be installed in between the sections of the curtain wall systems on the north and south faces of the Life Sciences Building.

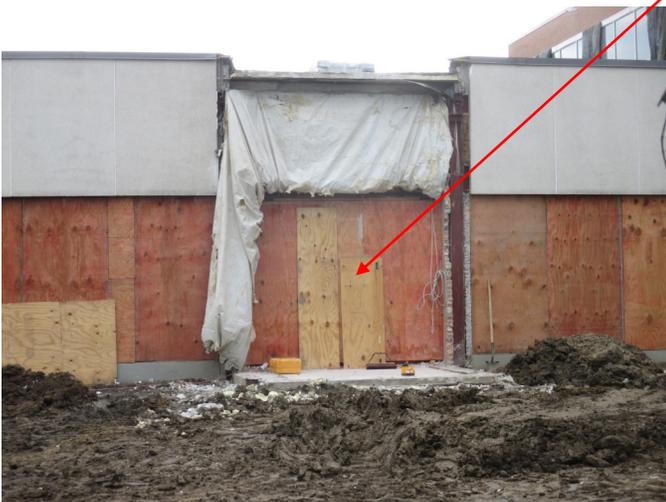
The bottom-left photo shows the completed demolition of the old north-west entrance to the Life Sciences Building. This entrance is not being renovated like the other entrances, but is instead being completely replaced as part of the addition. This entrance was not compliant with current building codes as far as accessibility standards, however the replacement will be.
