5-Year Master Plan

MONROE COUNTY
COMMUNITY COLLEGE

MONROE COUNTY COMMUNITY COLLEGE
FACILITIES ASSESSMENT AND DEFERRED MAINTENANCE
CAPITAL PLANNING REPORT
2008 UPDATE

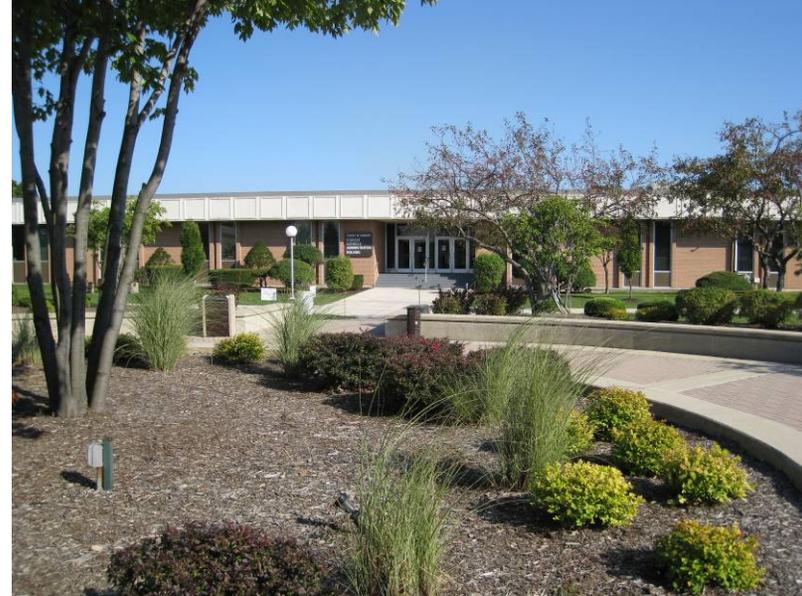
- Galvanized piping throughout is near or at end of life. Assume replacement or epoxy lining within 10 years.
- Original aluminum doors recently cleaned and thresholds replaced. Doors remain in poor condition, hardware worn, at end of life and due for replacement.

- Glass covered walkway between this and East Technology Building leaks in multiple locations. Repaired repeatedly, but steel rusting, paint peeling.
- South entry slab and steps cracked and deteriorating; stair nosings are loose.

- East entry concrete steps poorly constructed - risers vary in height, treads are too shallow and uneven. Creates tripping hazard

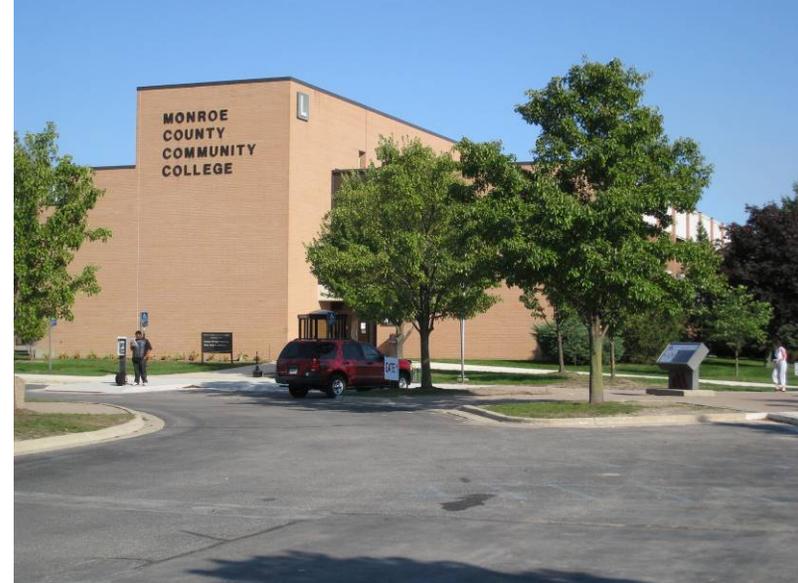
- Foundation cracking is present along west end of the building (not north as previously noted). No evidence of further movement.
- Walls in west stairwell in poor condition, interior walls in northeast corner chemistry labs on 2nd floor cracked. Condition stabilized several years ago, will require routine monitoring.

- Structure Tek rating is 50 out of 100 for the roof.
- No reported roof leaks; however roof sealant joints are failing, flashings are nearing end of life and due for replacement. Some pre-cast concrete roof coping stones are cupping. Affected stones should be removed and replaced or covered to prevent water infiltration into the wall.

- Window framing system is leaking and due for replacement
- Greenhouse operators are non-functioning and are due for replacement
- Sealant joints at pre-cast concrete spandrel panels are at end of life and are due for replacement.

- East AHU had the original galvanized cooling coil drip pan replaced with a SSTL unit. West AHU requires the same procedure at a cost of approximately \$20,000

- Reheat control valves, isolation valves, and thermostats are at end of life and are due for replacement
- MCCC completed a test project in 2007 using Cura-flow process of physically cleaning fouled water lines and then lining the piping with a permanent epoxy lining. Process is considered to be a 30 year solution. If this installation proves successful, other buildings may be completed using the process.

- Office carpet at end of life

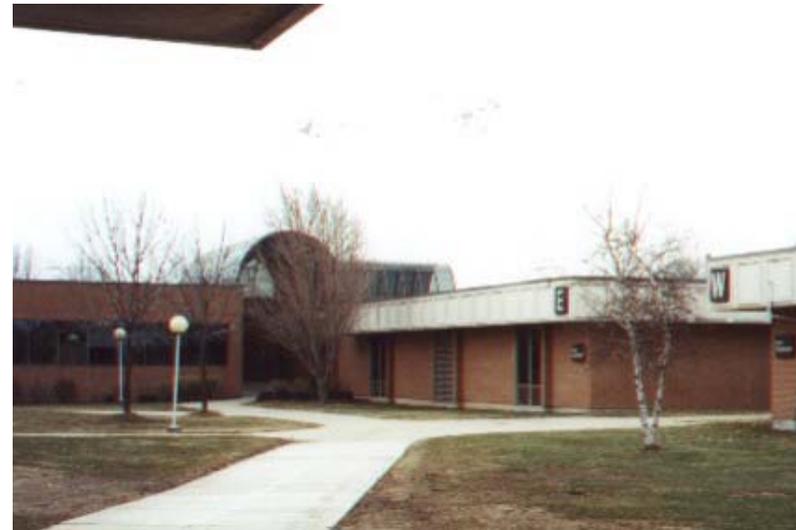
- Building structure leaks at room E-125, not traced to roof, may be from newer canopy connection.
- Structure Tek rating is 50 out of 100 for the roof.

- Roof sealant joints failing, flashings are nearing end of life and due for replacement
- Two-part, non-insulated glazing is typical throughout with no reported problems. Weather stripping is failing and requires ongoing maintenance. Windows are nearing end of life.

- Shifting fascia panels result in on-going sealant issues and misalignment. Recommend on-going monitoring.
- Underside of covered walkway canopy between East Tech and West Tech needs repainting (from water damage) - leak repaired, problem has returned.

- Reheat control valves, isolation valves, and thermostats are at end of life and are due for replacement
- Domestic hot water lines are fouled and near end of life.

- Doors recently cleaned and thresholds replaced. Doors remain in poor condition, hardware worn, all at end of life and due for replacement.
- Walk between East and West Tech buildings heaving, potential trip hazard.

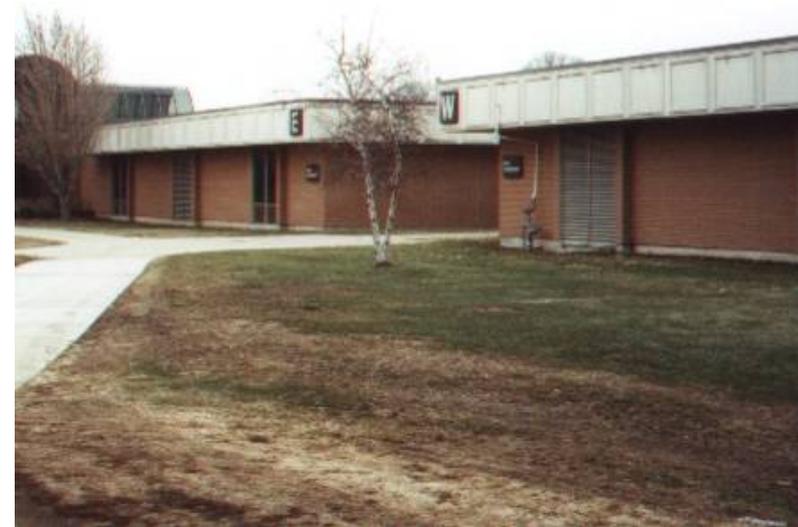
- Minor water / moisture infiltration within basement at wall penetrations.
- Structure Tek rating is 50 out of 100 for the roof.
- Infrared images indicate areas of moisture within the insulation at the SW corner of the roof. Leaks will require corrective action.

- Roof sealant joints failing, flashings are nearing end of life and due for replacement
- Two-part, non-insulated glazing is typical throughout, nearing end of life. Weather stripping is failing and requires ongoing maintenance. Windows are nearing end of life.

- Precast concrete fascia panels continue to move resulting in ongoing sealant failure.
- Galvanized piping throughout is near or at end of life. Water is fouled when first used. MCCC anticipates ongoing maintenance issues.

- Reheat control valves, isolation valves, and thermostats are at end of life and are due for replacement
- Cracking was observed in an corridor wall within room 164. The cause of the cracking is unknown; source may be vibration from the adjacent AHU. Recommend annual monitoring.

- Original aluminum doors recently cleaned and thresholds replaced. Doors remain in poor condition, hardware worn, all at end of life and due for replacement.

- Floor in hydraulics lab is cracked, damaged, and due for replacement.
- Entry vestibules are too shallow to meet current accessibility guidelines.

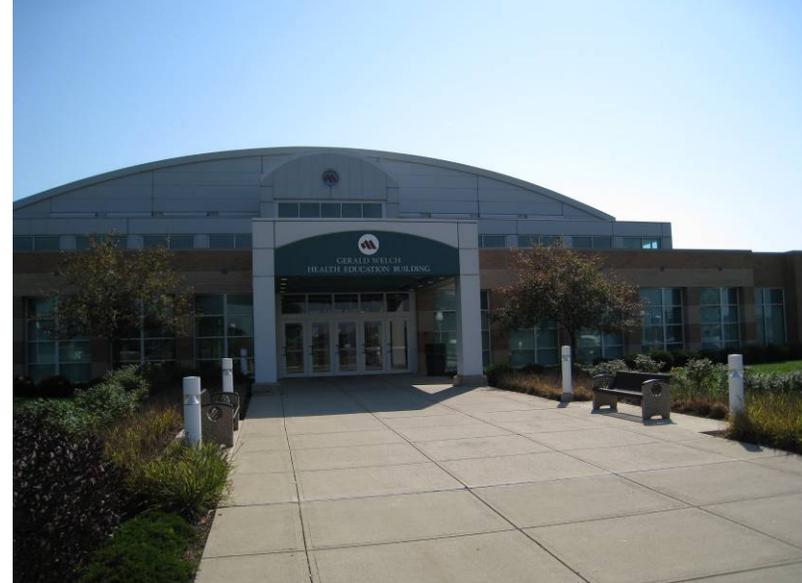
- Interior expansion joints not continuous from floor to walls, potential for future problems.
- Structure Tek rating is 70 out of 100 for the roof.
- Infrared images indicate a few areas of wet insulation. These areas are marked on the roof and will be repaired. Roof sealant joints failing, flashings are nearing end of life and due for replacement.

- Clerestory windows have a number of failed glazing units; seals have failed trapping moisture within the unit. On-going failure may be due to excessive system deflection.

- Window framing (Tubelite 1400 Series) has a number of water handling / weep problems resulting in moisture problems within the building. Structure Tek has conducted field-testing to identify sources of leaks. The College continues to address this ongoing concern.

- Masonry veneer was apparently installed with insufficient expansion / movement control joints. As a result the building experienced some masonry failures. The installation of movement joints has addressed the problem.

- Noise problems with gymnasium air handling unit, system can't be run at high speed when noise is a concern, causing space to be too hot.
- College pressure cleaned existing ceramic tile flooring reducing staining / soiling, but increasing the quantity and size of voids within the grout. Tile is telegraphing slab movement in some locations resulting in open joints.

- Entry slabs are settling; up to 1". To date the settlement has been even and has not resulted in trip hazards. Sealant line at expansion joints has failed and is due for replacement.

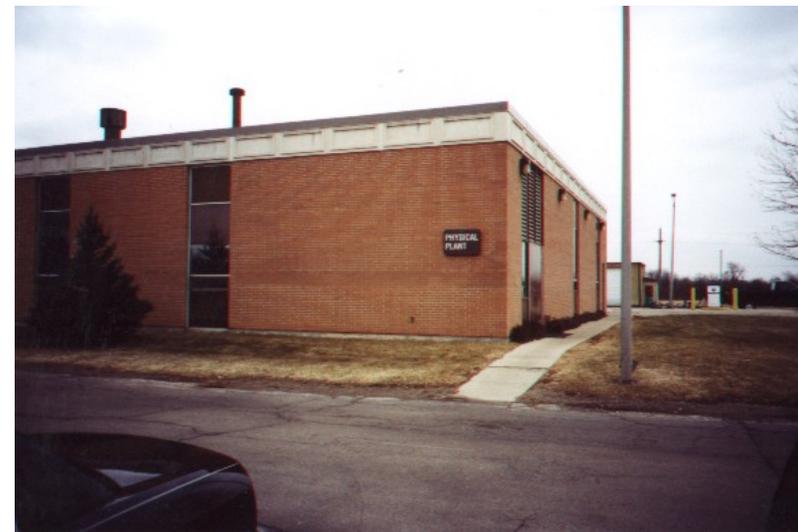
- Incidental cracking noted within CMU walls at a number of locations including the director's office. Cracking appears to be stabilized but should be monitored.
- 2008: Structure Tek rating is 70 out of 100 for the roof.
- Minimal glazing, original single pane.
- Absorption Chiller - Cooling Tower and tank: nearing end of life and will require replacement.
- Steam flow recorders replaced as part of control system upgrade.
- Building houses utility tie-in and is the 13,200V distribution source for the campus.
- Simplex Alarm panel (upgraded) with horn and strobe.
- Office space and toilet room not ADA compliant.

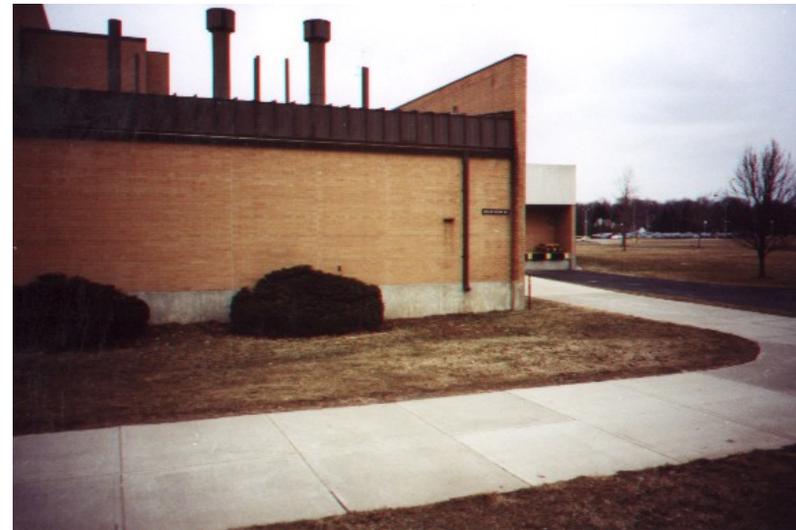
- Original standing seam metal roof. Roof is regularly inspected and has no reported problems.
- (2) original boilers: 1978-79. Boilers are annually inspected and maintained: Fire tubes show pitting on exterior. Tubes will require replacement in near future (3-5 years). College anticipates full boiler replacement by 2020.
- Steam flow recorders, replaced as part of Apogee system upgrade.
- Galvanized piping failing, main lines replaced. Balance of piping requires replacement of long sections when failure occurs. Entire piping system due for replacement.
- (2) domestic hot water tanks, one replaced in 1995 one replaced in 2000.

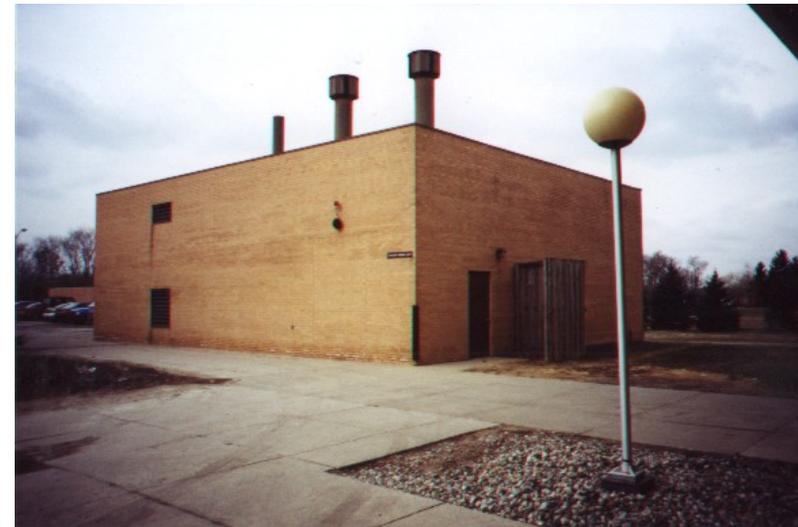
- Original standing seam metal roof. Roof is regularly inspected and has no reported problems.
- Masonry was recently tuck-pointed correcting previously noted damage.
- (2) Original boilers - 1978-79. Boilers are annually inspected and maintained: Fire tubes show pitting on exterior. Tubes will require replacement in near future (3-5 years) College anticipates replacement by 2020.
- 2 hot water tanks; one replaced in 2004 and a second tank added in 2005.
- Fire alarm is pull station only (no detection)

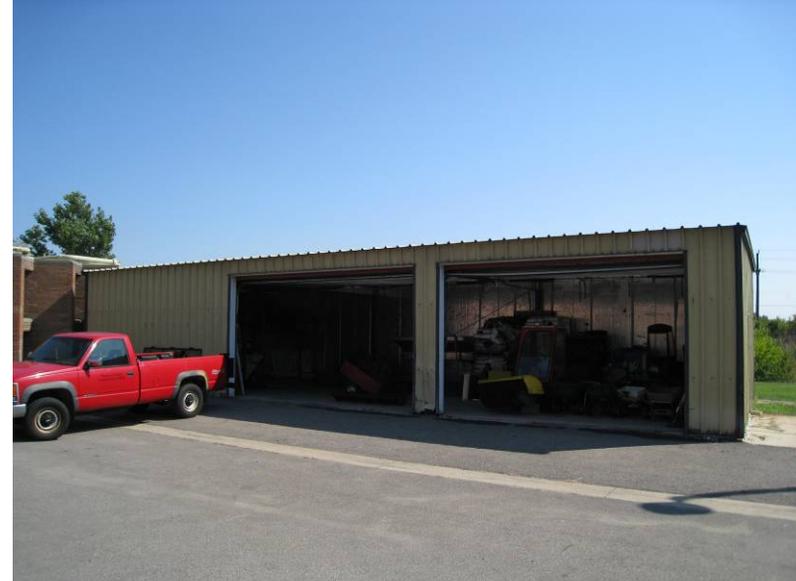
- Metal siding; cosmetic damage from vehicle / equipment impact. The resulting damage will allow water to enter the building. Condition should be corrected.
- (2) Overhead sectional doors replaced within last 10 years; no reported problems

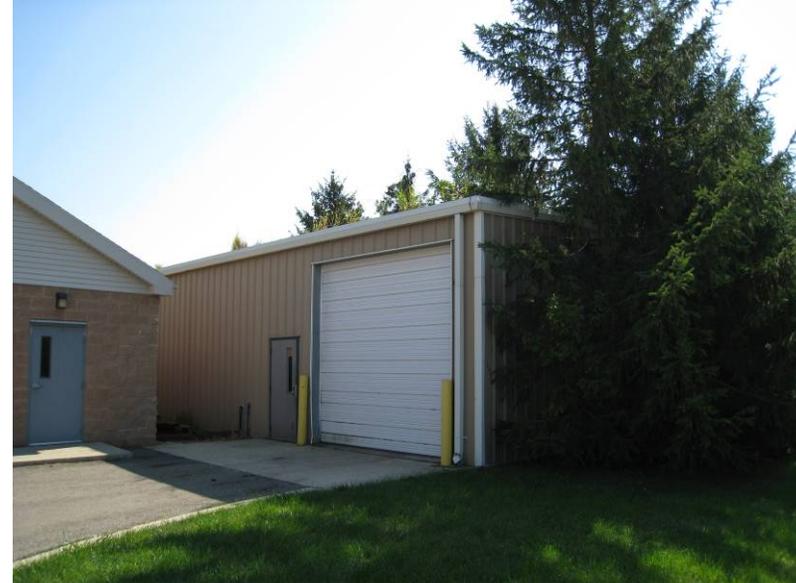
- Corrugated metal roofing panels with exposed, gasketed fasteners. Roof regularly inspected; no reported problems.
- Gutters were full of debris and non-functional.
- Corrugated metal siding panels appear to have original, factory finish - nearing end of life.
- Natural gas line installed from SAE Building to the Technology Building was run above grade and is protected from damage by a large steel pipe. This installation is not code compliant and should be corrected.

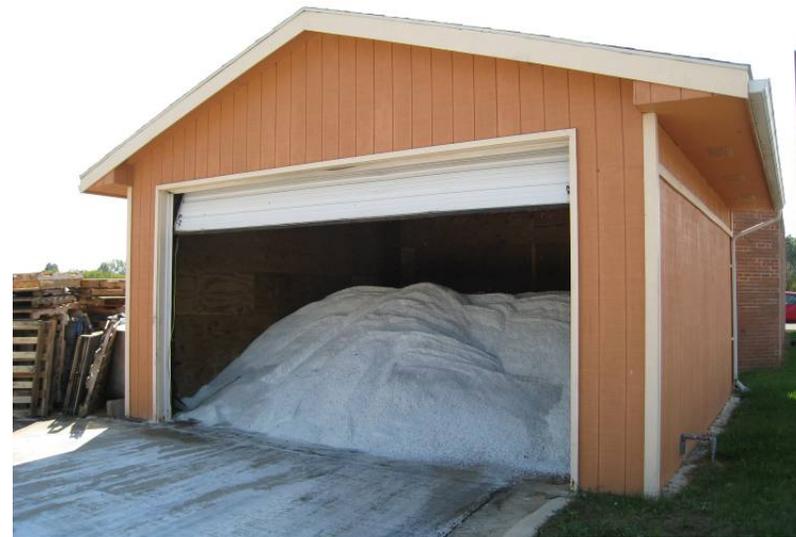
- Salt has pushed the rear wall of the building out of plane. Currently the wall is restrained using a series of wooden braces. Wall should be restored to plumb and level condition once the salt supply is emptied.
- No reported roofing problems. Roof was not included in Structure Tek's review of campus roofing condition.
- Overhead door tracks and associated door hardware are failing due to the corrosive nature of the salt and are nearing end of useful life.

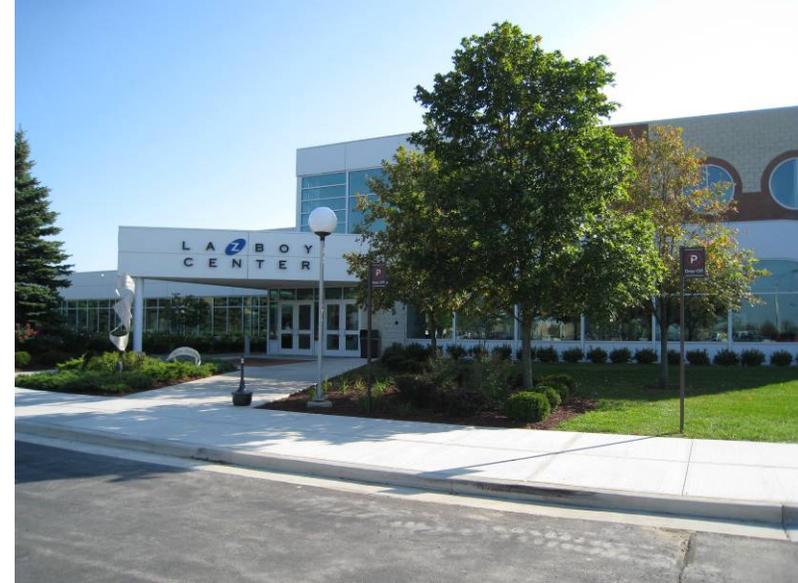
- Coping metal at metal panel system does not properly slope back to the roof. A line of sealant was added to keep water from streaking the visible face of the metal panels. Condition should be carefully monitored for evidence of water infiltration into and behind the metal panel system

- Structure Tek rating is 85 out of 100 for the roof. Previously identified leaks have been repaired
- Sealant where window frames abut metal panel system is failing and is due for replacement.

- Exterior soffit: Synthetic stucco on cementitious backer panels is cracking at panel joints. At time of walk-through one panel had failed, fell from the building, and needed to be refinished.

- Exterior masonry joints are beginning to age and will require tuck-pointing in the near future. Masonry expansion / control joint sealants are likewise nearing end of life and will require general repair and replacement. Masonry was cleaned to remove evidence of post-construction efflorescence. At time of walk-through efflorescence was returning in selected areas

- -The building has experienced a number of electronic component failures including multiple fire alarm panel boards, boiler flame sensors, VFD controllers, and CW pump starters. These could be independent failures or symptoms of a larger problem.

- Broadloom carpeting in the main lobby has a number of seam failures and has some buckling at the walls. This may be due to poor installation. Carpet in these areas will require replacement soon. Stage flooring is scheduled and funded for sanding and regular maintenance.

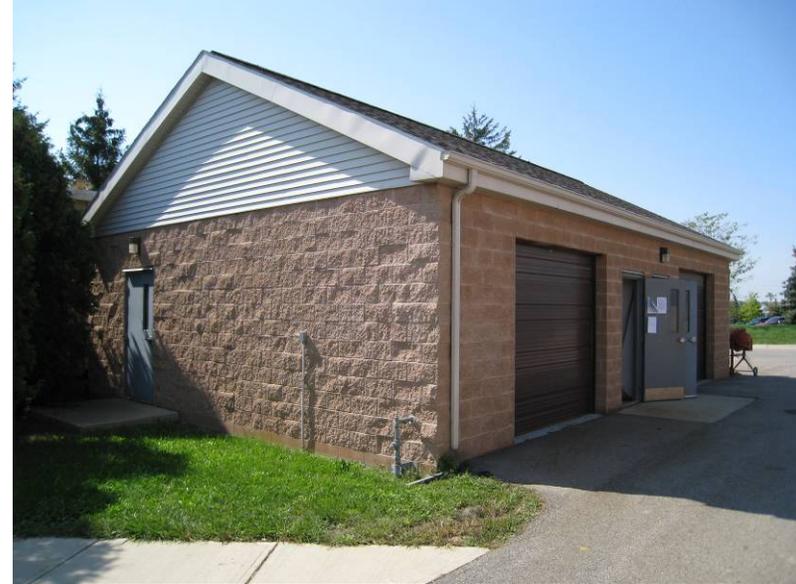
- Roof was not included in Structure Tek's review of campus roofing condition.
- Gutters currently drain to immediate grade. Splash blocks should be installed to limit splash onto the building
- Doors and frames are protected with primer only. Doors and frames should be painted to protect them from moisture damage.
- Dedicated alarm panel with pull stations, horn, and strobe
- Battery powered emergency exit lighting

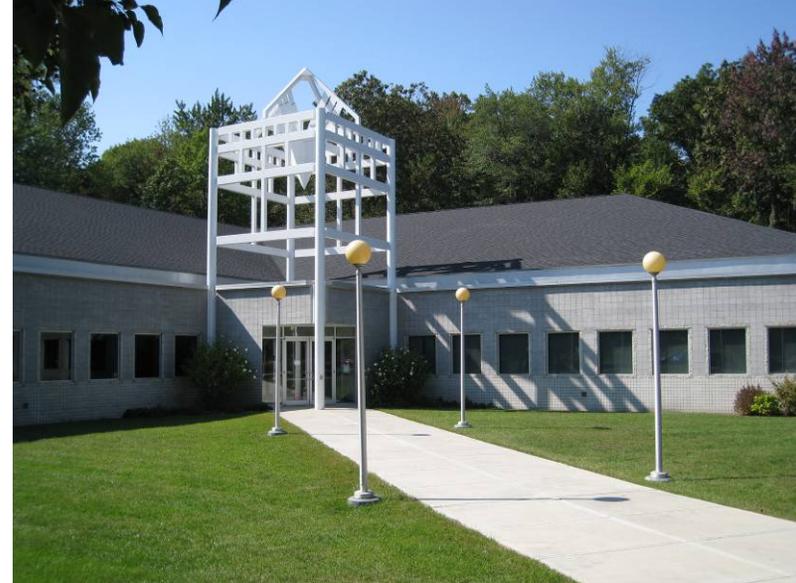
- Structure Tek rating is 70 out of 100 for the roof.
- Plastic laminate sills are failing and are due for replacement. Evidence of moisture infiltration at and around windows. Refer to Walls for additional information.

- Monitor moisture levels within CMU veneer masonry. Topical sealer may aid in limiting moisture infiltration and also reduce evidence of moss / mildew on the north side of the building.

- Burnished CMU were cleaned in 2007 to remove efflorescence. Walls were also tuck-pointed and re-sealed. Aluminum fascia panels were replaced in 2006 when the composition roofing was replaced.

- Domestic hot water heater was recently replaced. No reported problems.
- College has experienced on-going electrical problems with the facility. An observed power factor of .70 led the College to install a Power Conditioning Capacitor. College plans to install a new meter for monitoring and data logging to evaluate the effectiveness of the unit.

- College is self-performing corrections to cracking and moisture damage. College is installing isolation joints to reduce the appearance of future cracking in some location. This may prove to be a temporary correction. During walk-through evidence of a moisture 'bloom' was observed near one of the entries. Source of moisture should be identified and corrected.
