MONROE COUNTY
COMMUNITY COLLEGE

5-Year Master Plan

OCTOBER / 2013

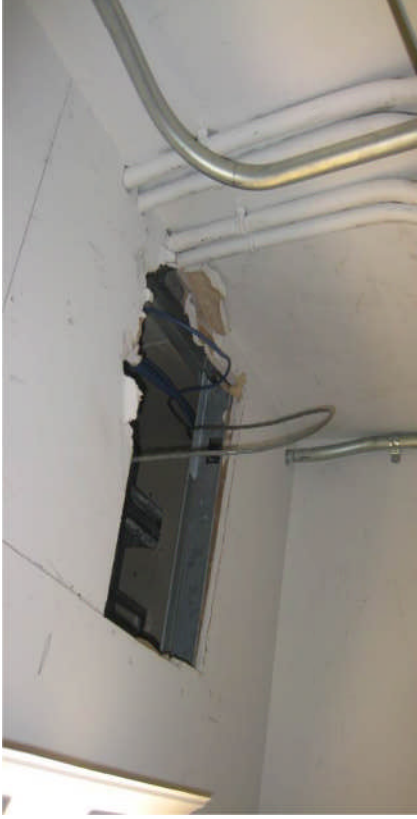
Whitman Center – breach in fire-rated ceiling assembly.

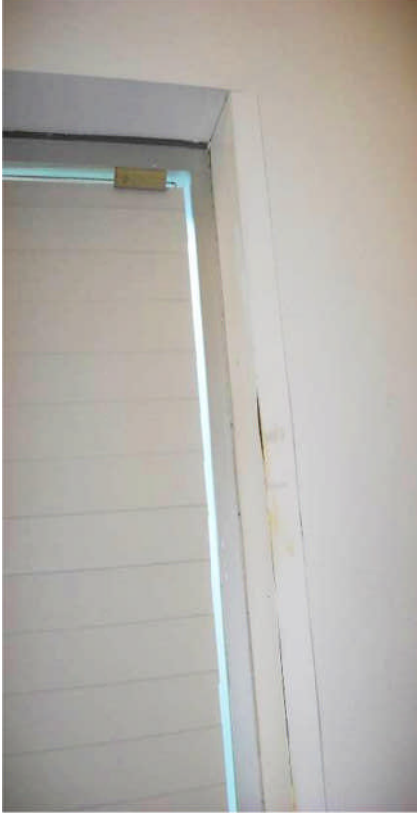
Whitman Center – water infiltration along exterior wall has caused deterioration of the plastic-laminated windowsills.

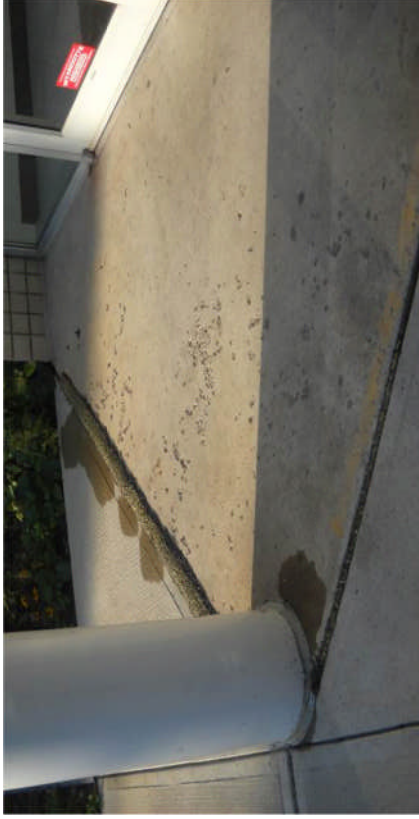
Whitman Center – settlement/heaving of exterior concrete slab (at main entrance) presents a tripping hazard.

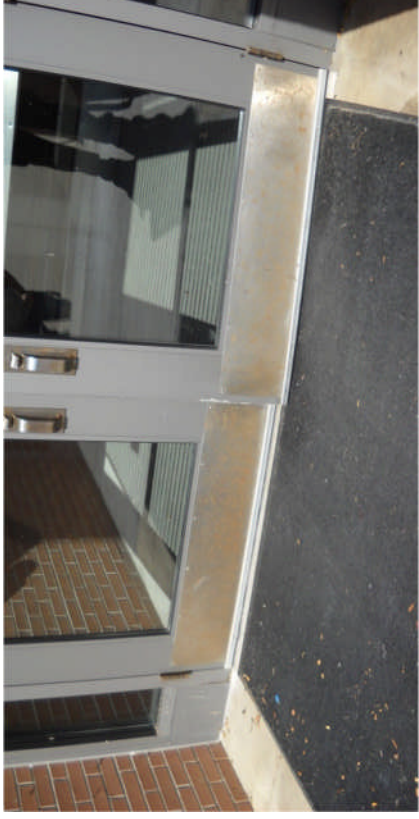
Student Services/Administration - Aluminum entrance doors and hardware at end of life.

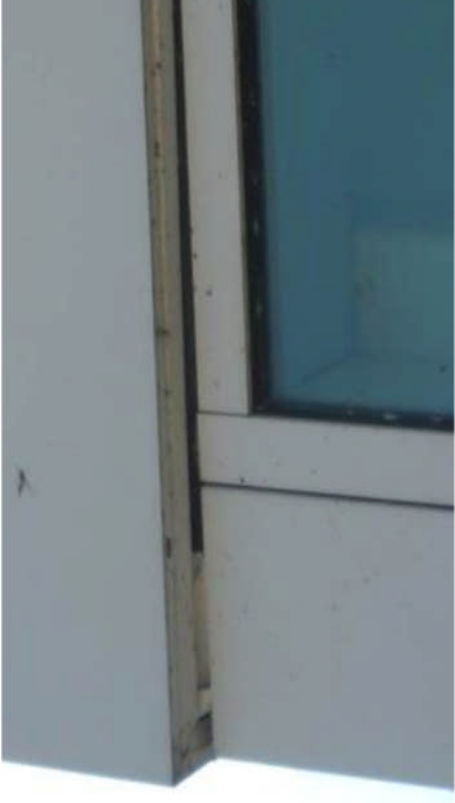
La-Z-Boy Center – It appears there is a void within the exterior aluminum, curtain wall assembly allowing the environment to enter the interior.

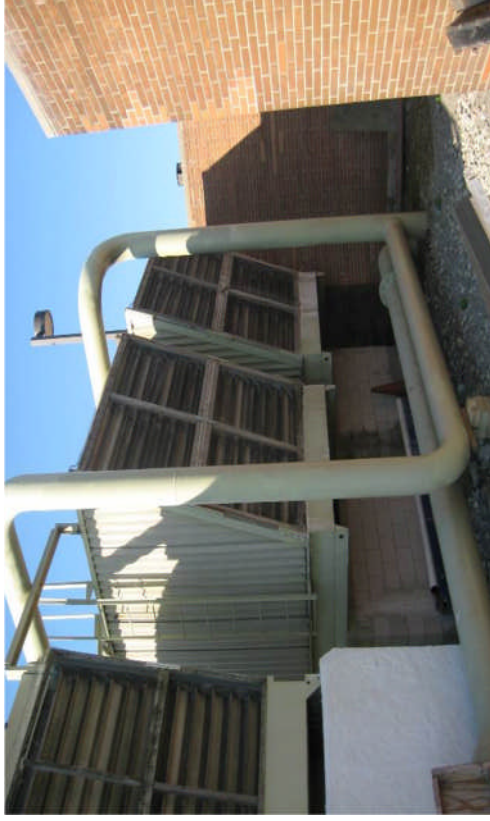
Physical Plant – Cooling tower and basins are near end of life.

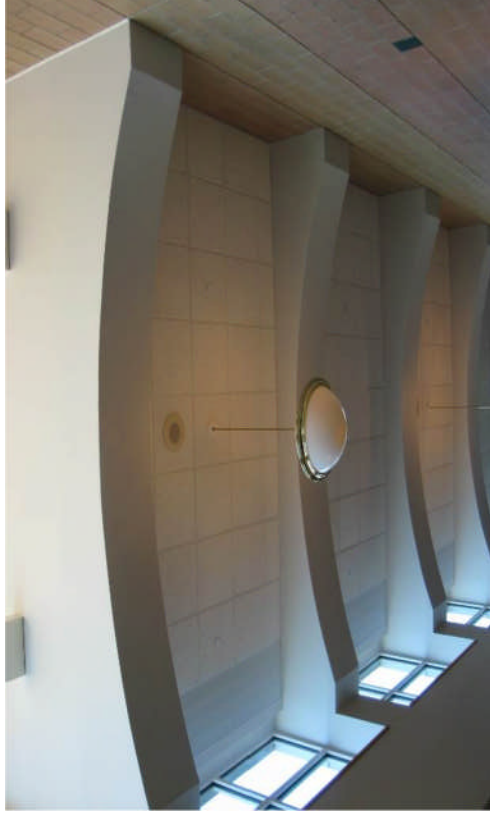
Health Education Building – Daylighting controls for the Atrium would save energy.

- A permanent solution to the Electrical Vault flooding issue is needed to remediate the problem.
- Daylighting control of the Atrium fluorescent fixtures should be considered for energy savings.

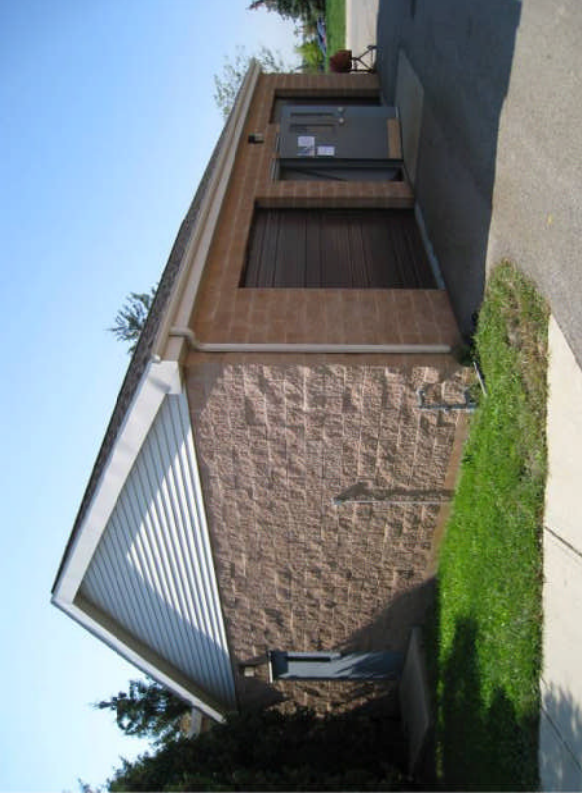
Observation Highlights:

- Cracks in CMU exterior wall, primarily at the ends of steel lintels over the overhead sectional doors should be monitored.
- No reported roofing problems. Roof evaluation was not included in PSI's roofing condition report. No visual defects were noted.
- Gutters currently drain to immediate grade. Splash blocks should be installed to limit splash onto the building
- Doors and frames are protected with primer only. Doors and frames should be painted to protect them from moisture damage.

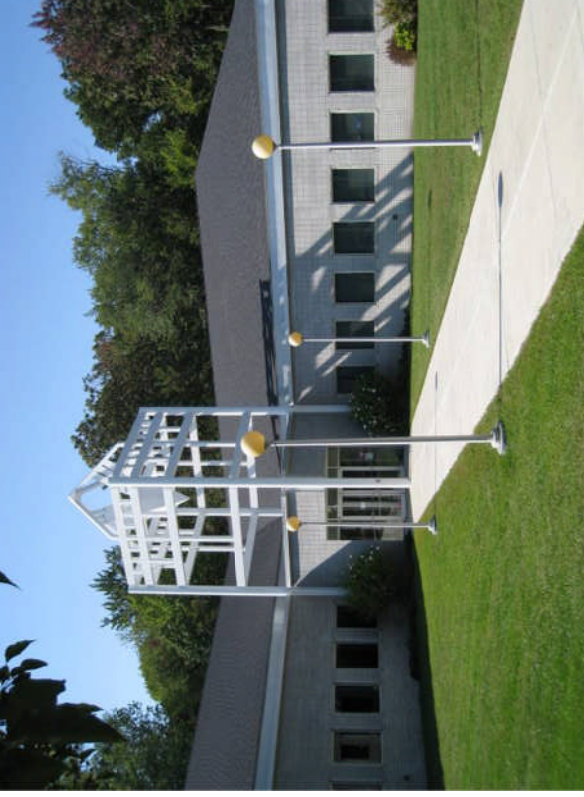
- PSI rates the flat roof condition as “generally in fair to good condition” and the sloped roof is in “generally good condition.” Flat roof over Main Entry is in generally poor condition.

- Plastic laminate windowsills are failing and due for replacement. Evidence of moisture infiltration at and around windows.
- Monitor moisture levels within CMU veneer masonry. Topical sealer may aid in limiting moisture infiltration and reduce evidence of moss/mildew on the north side of the building.

- IT closet near the Lobby requires ventilation to remove heat build-up.
- Repair 12” x 12” hole in closet fire-rated ceiling near Lobby.
- Repair small hole in Maintenance Room fire-rated wall near Lobby.

- Wireless equipment is at end of life and requires replacement.
- Corrections to cracking and moisture damage at Lobby were performed, recommend that condition is monitored. Isolation joints were installed to reduce the appearance of future cracking in some locations. This may prove to be a temporary correction.

- College has replaced fire alarm panel.
- Student Lounge Area exterior concrete slab joint material between sections needs replacing.
