MONROE COUNTY  
COMMUNITY COLLEGE

# 5-Year Master Plan

# Monroe County Community College

October 2014

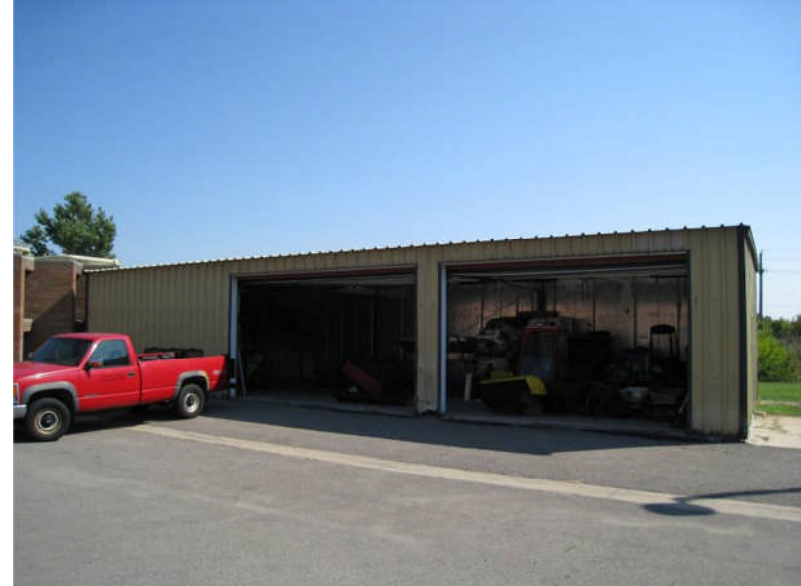
- Metal siding has cosmetic damage from vehicle / equipment impacts. The resulting damage will allow water to enter the building. Condition should be corrected.

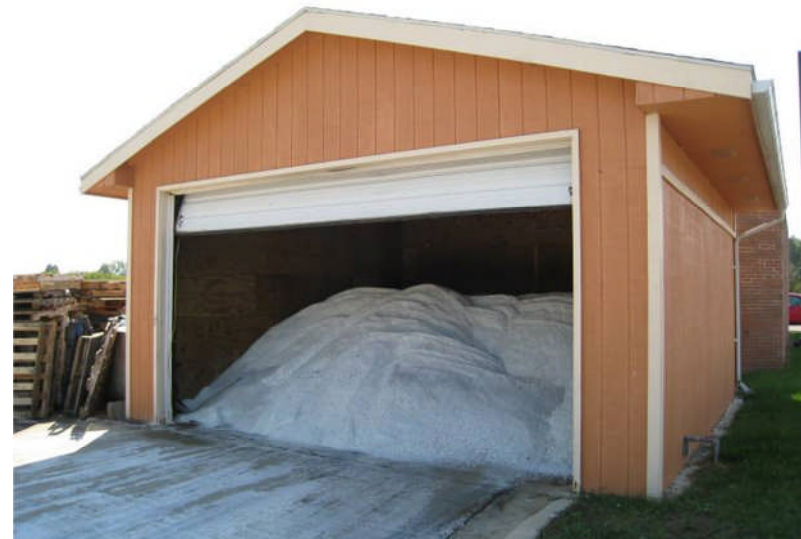
- Salt has pushed the rear wall of the building out of plane. Currently the wall is restrained using a series of wooden braces. Wall should be restored to plumb and level condition once the salt supply is emptied.
- No reported roofing problems. Roof evaluation was not included in PSI's roofing condition report. No visual defects were noted.
- Overhead door tracks and associated door hardware are failing due to the corrosive nature of the salt and are nearing end of useful life.
- No visual inspection of floor surface was possible.

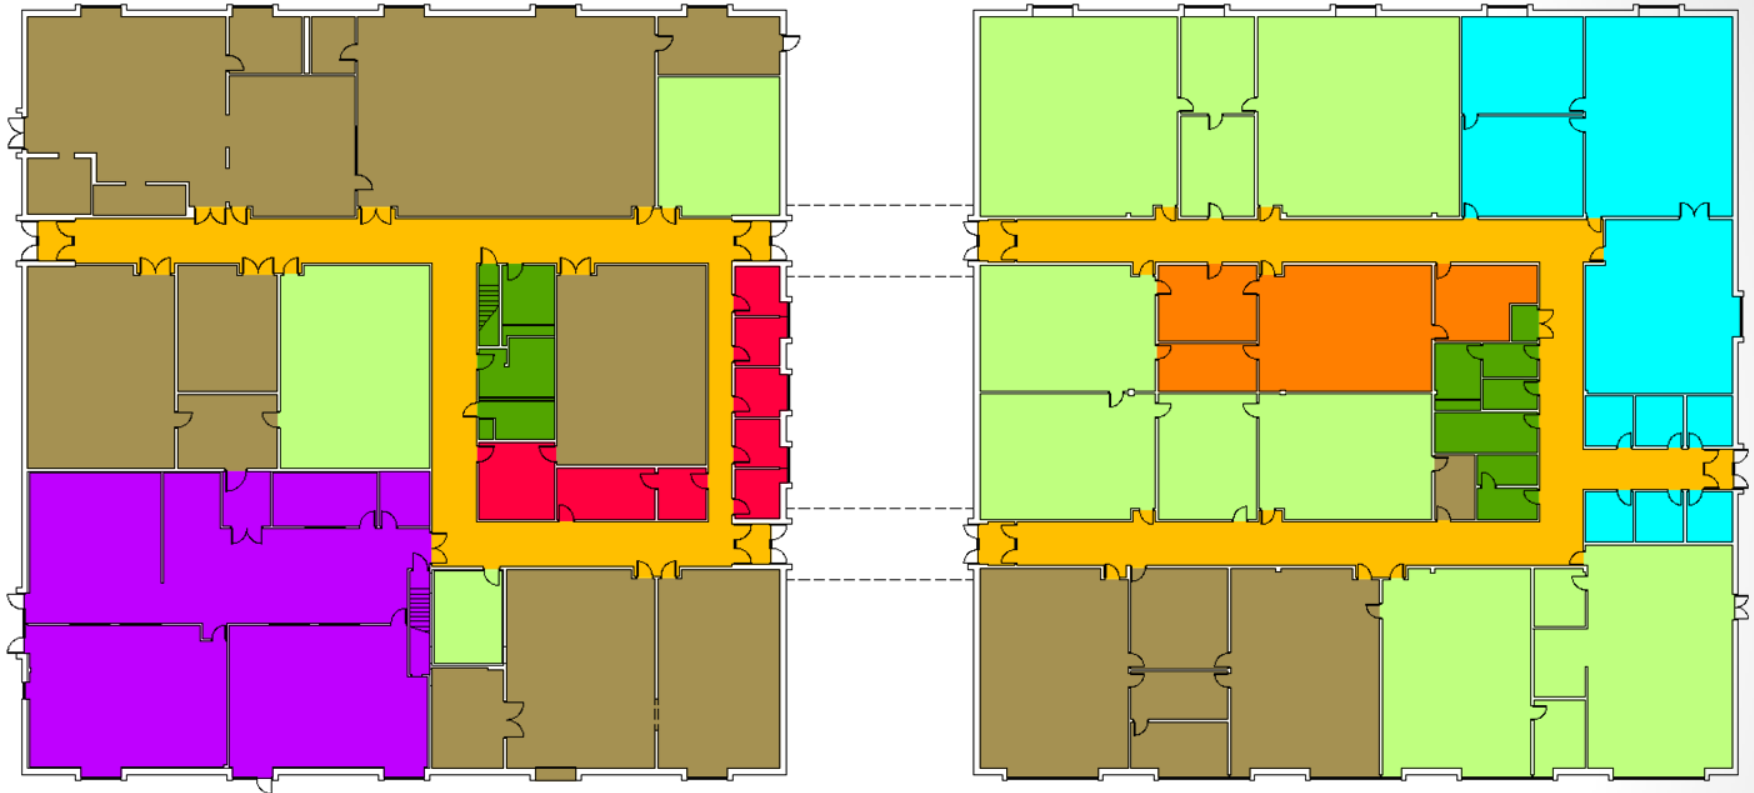
## EXISTING FLOOR PLANS

# East & West Technology Building Renovations

Building Areas: East Tech = 23,117 sf | West Tech = 23,108 sf

Classrooms and laboratories in the East Technology Building and the West Technology Building are currently offline as they need to be renovated before they can be usable instructional space.

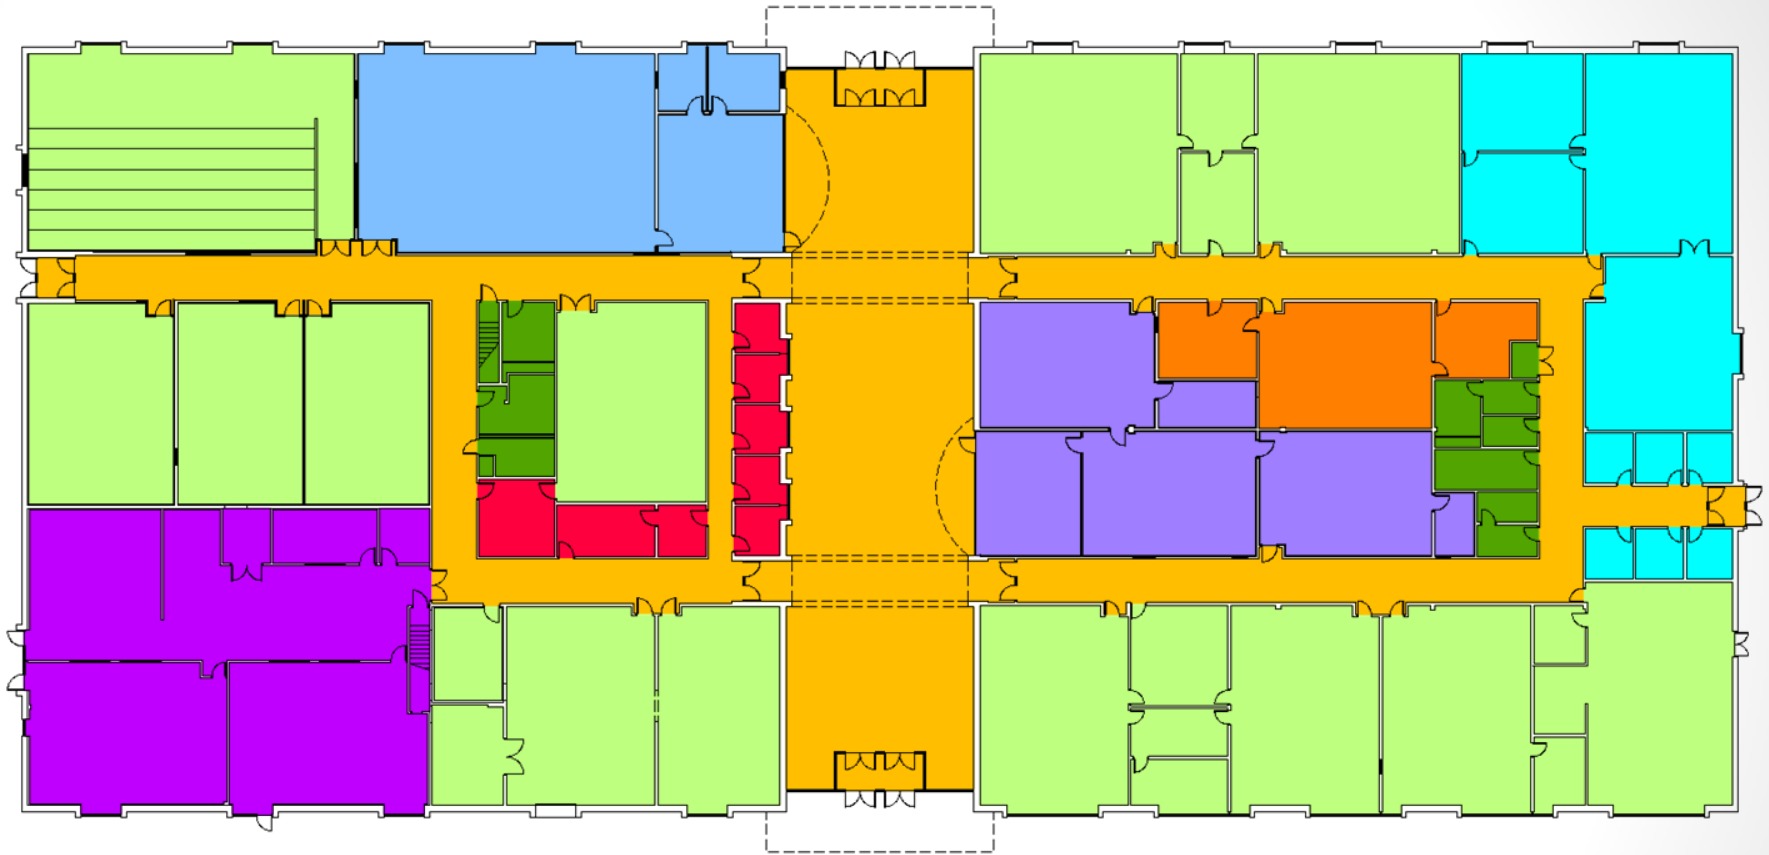
## PROPOSED FLOOR PLAN

# East & West Technology Building Renovations

Building Areas : Existing = 46,225 sf | New = 5,245 sf | Total = 51,470 sf
