MONROE COUNTY
COMMUNITY COLLEGE

5-Year Capital Outlay Plan

SEPTEMBER | 2024

5-Year Master Plan

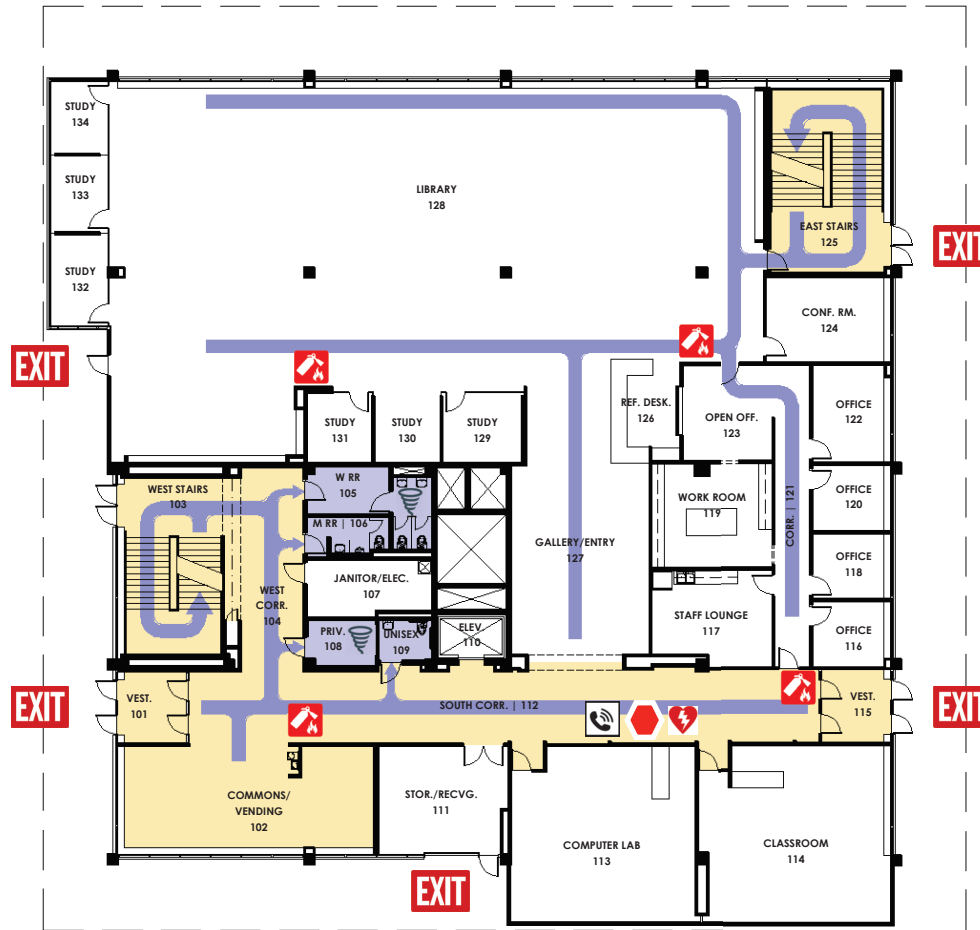
Campbell Academic Center Emergency Plan | 1st Floor

Note: Please proceed to the lower level for the designated tornado shelters.

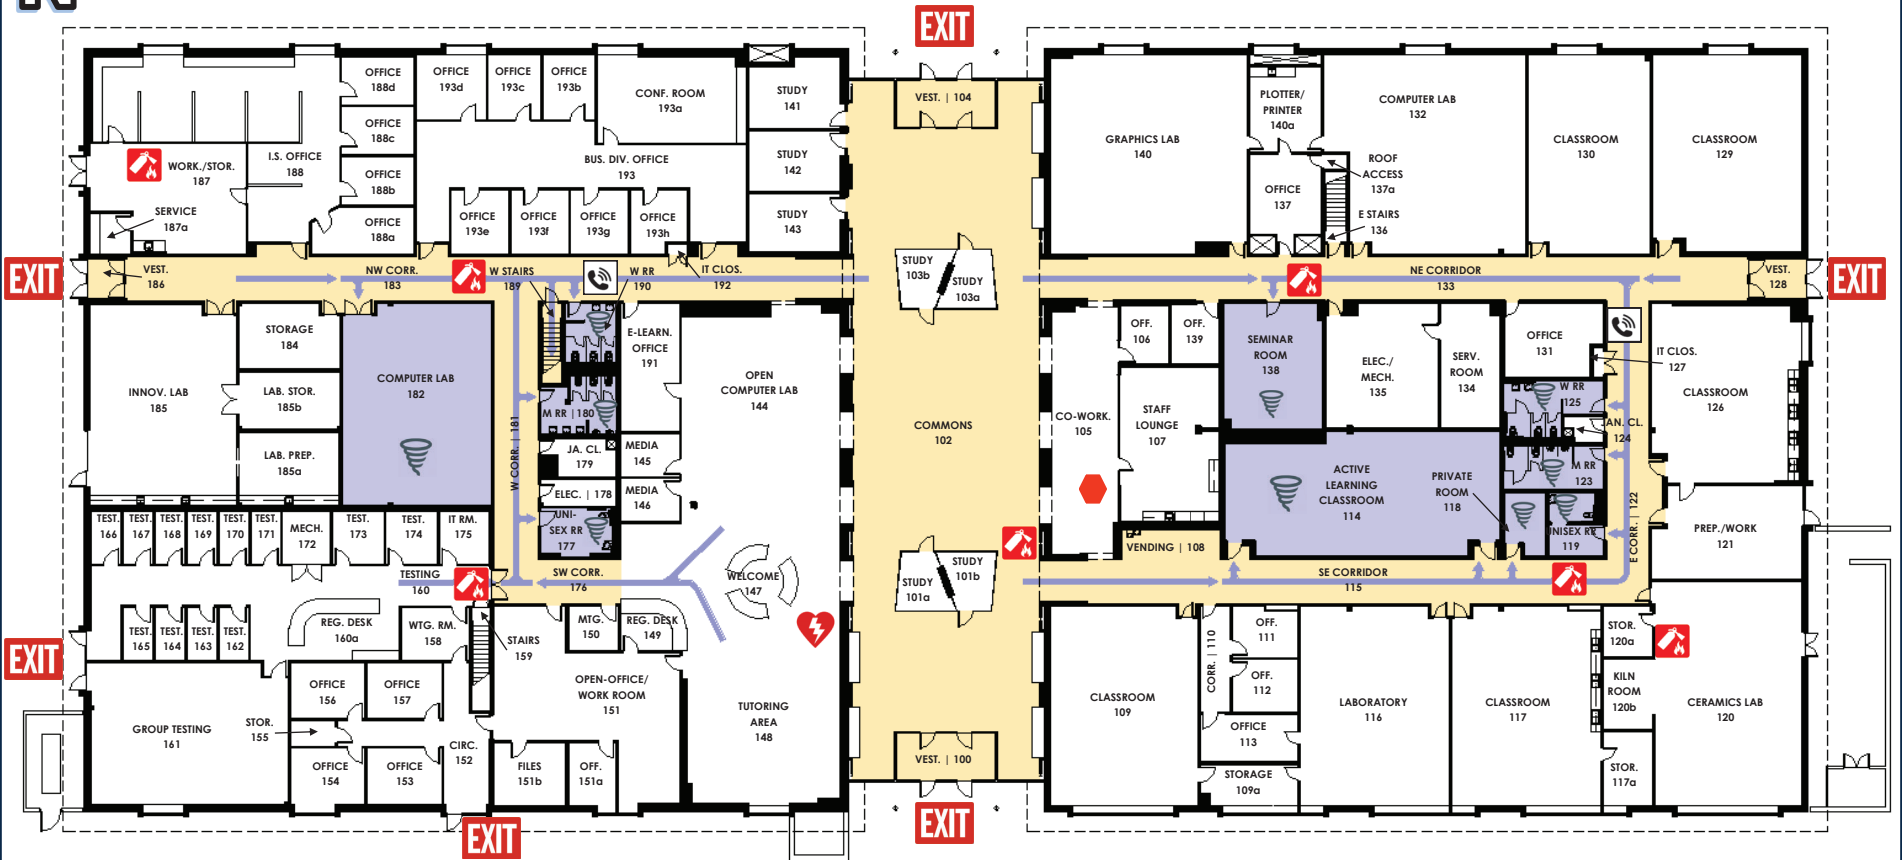
Founders Hall Emergency Plan

Note: The basement also serves as a designated tornado shelter. It can be accessed via the door on the west side of the building near the restrooms.

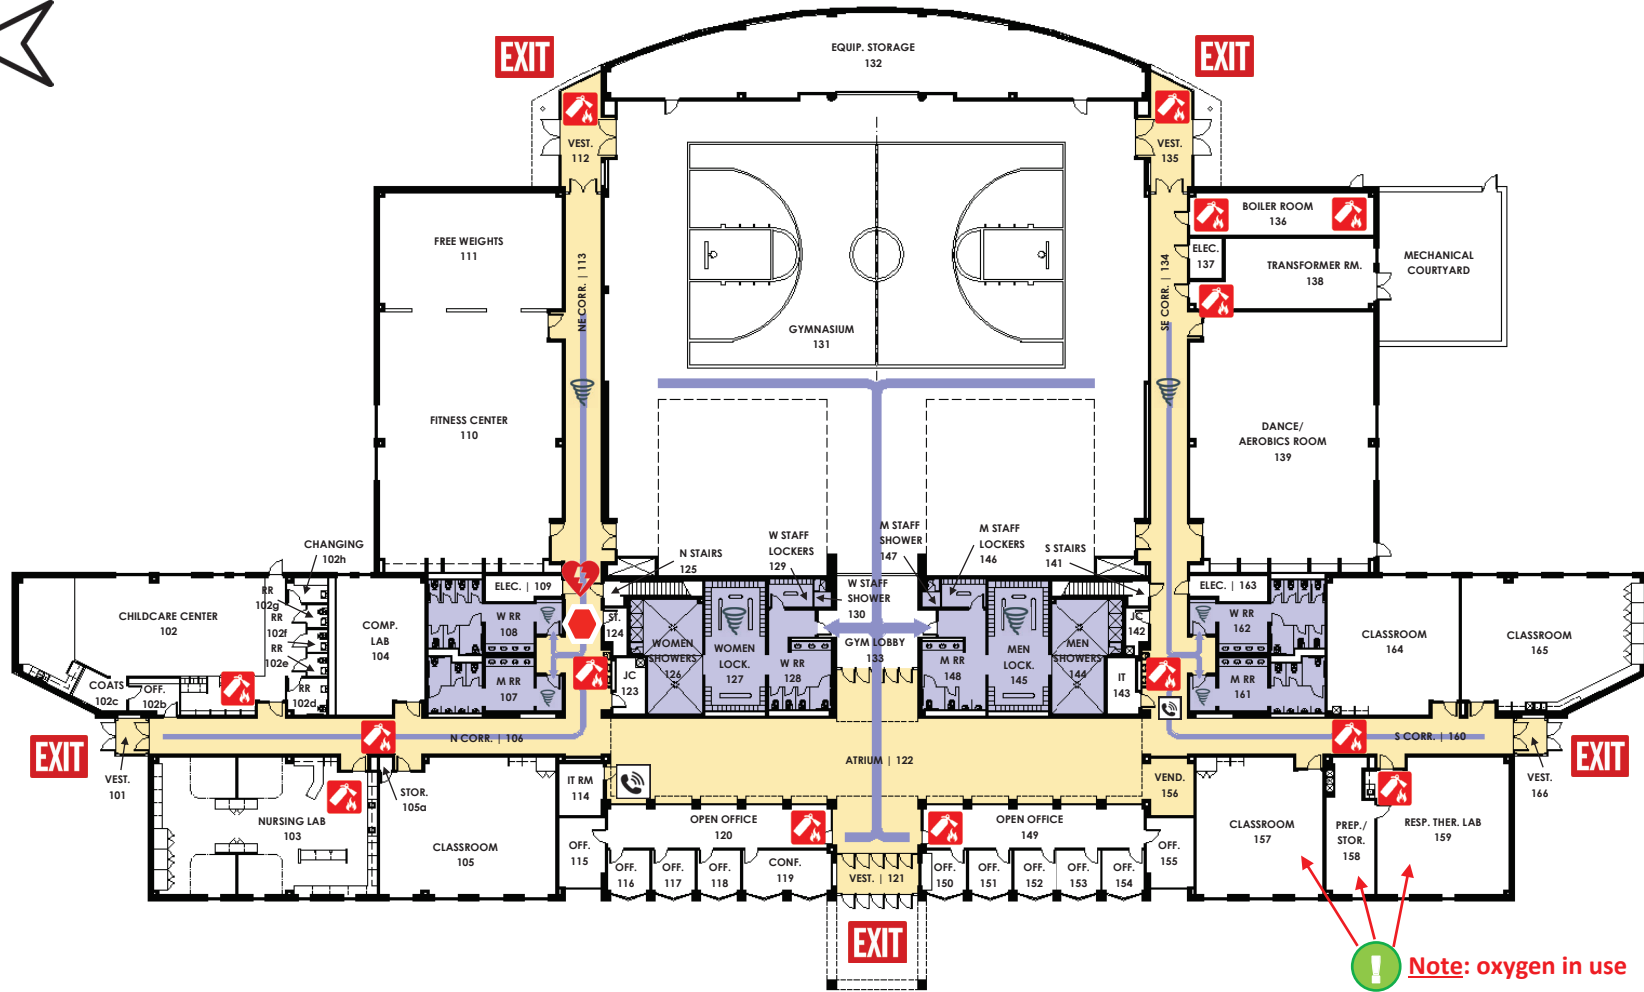
Welch Health Education Building Emergency Plan

**Note: oxygen in use**

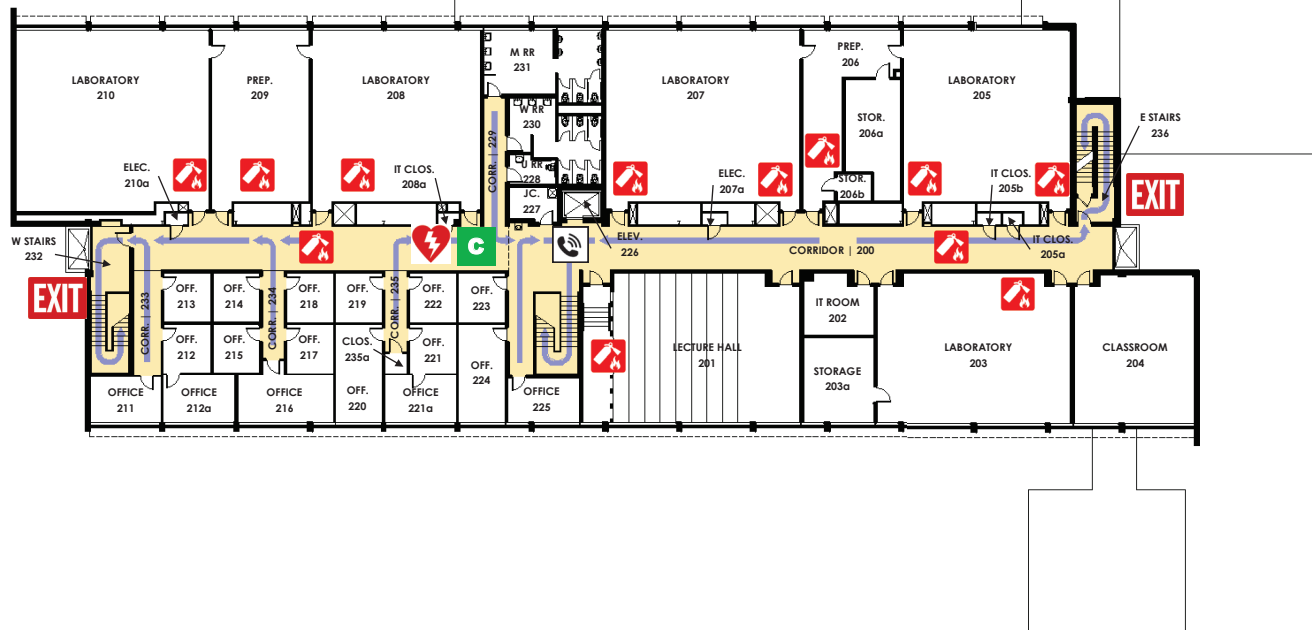
Note: Please proceed to the 1st floor for the designated tornado shelters.

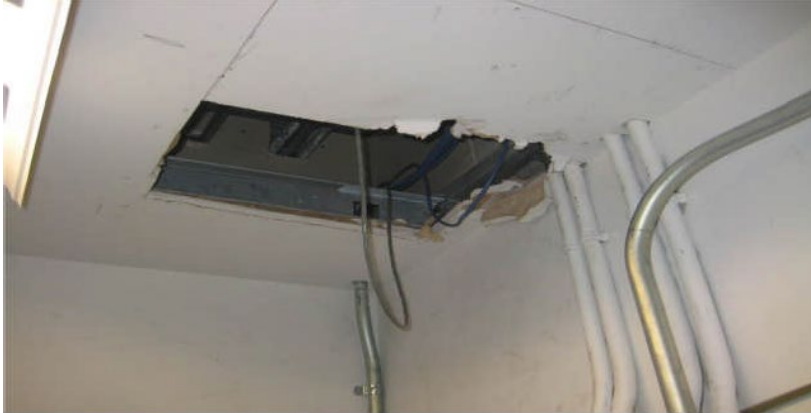
Whitman Center – breach in fire-rated ceiling assembly.

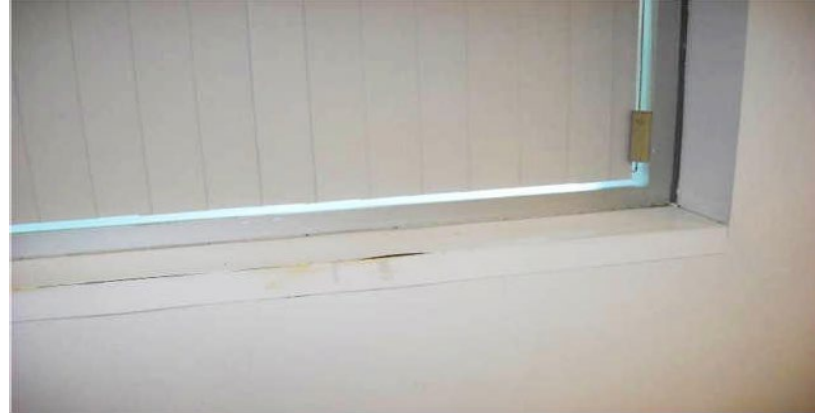
Whitman Center – water infiltration along exterior wall has caused deterioration of the plastic-laminated windowsills.

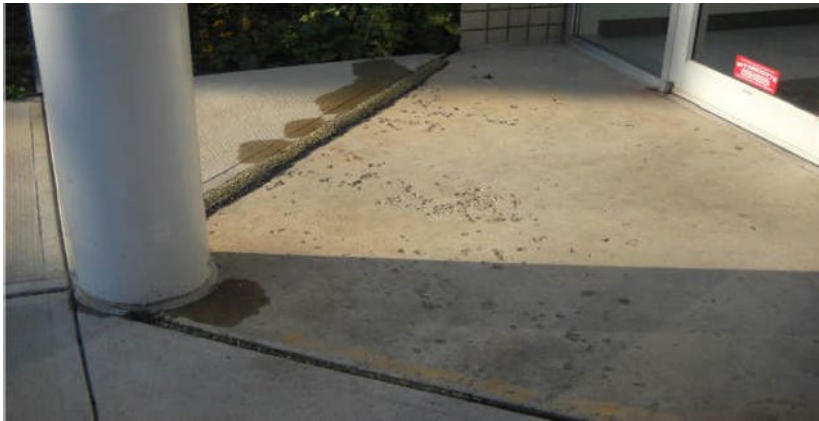
Whitman Center – settlement/heaving of exterior concrete slab (at main entrance) presents a tripping hazard.

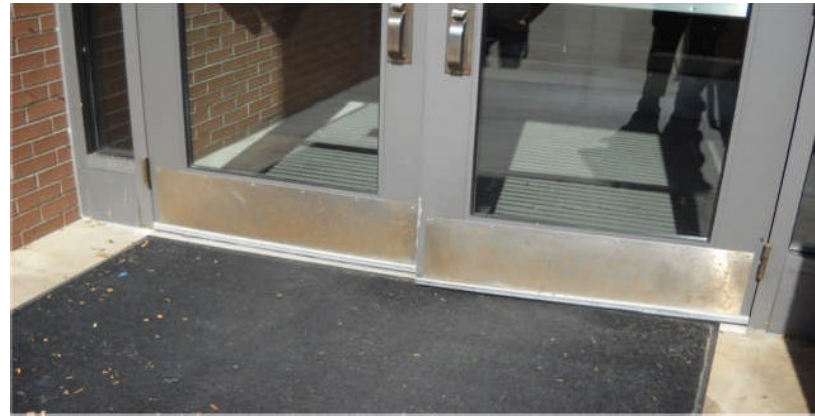
Student Services/Administration - Aluminum entrance doors and hardware at end of life.

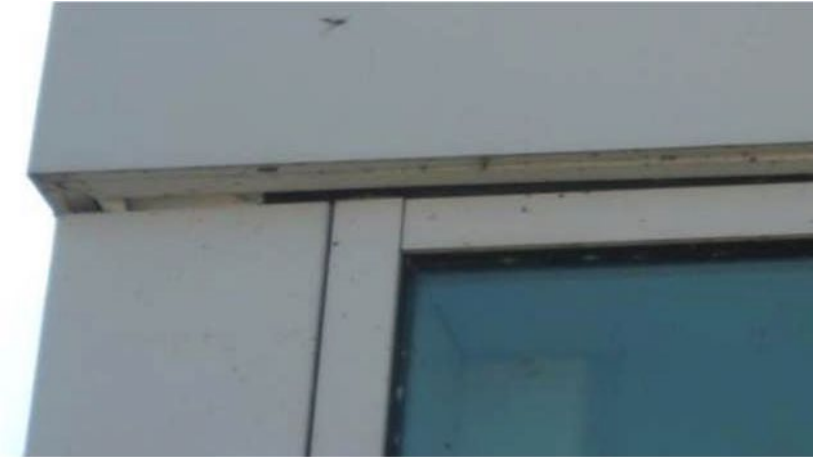
La-Z-Boy Center – It appears there is a void within the exterior aluminum, curtain wall assembly allowing the environment to enter the interior.

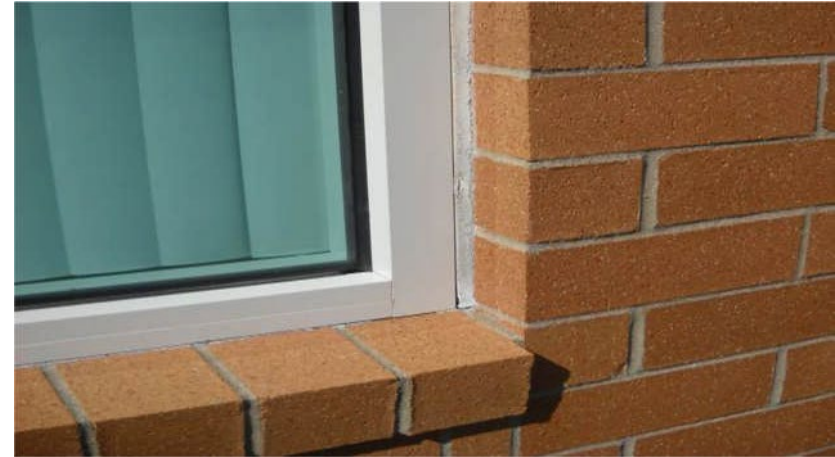
Health Education Building – Typical sealant joint is at end of life.

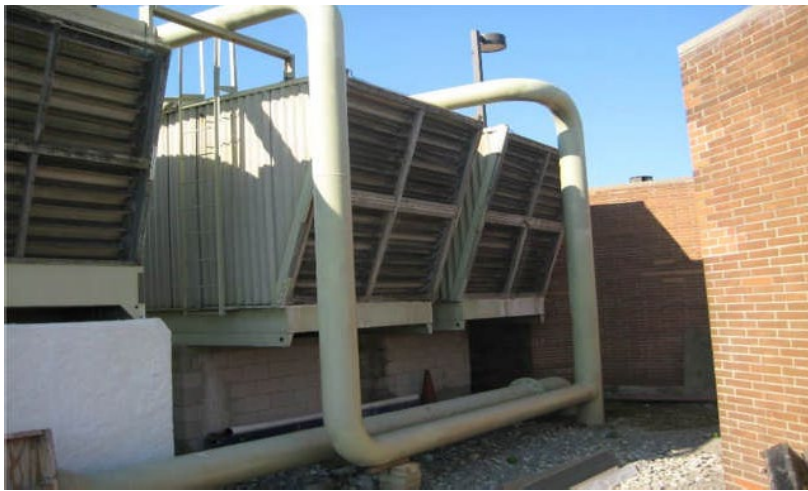
Physical Plant – Cooling tower and basins are near end of life.

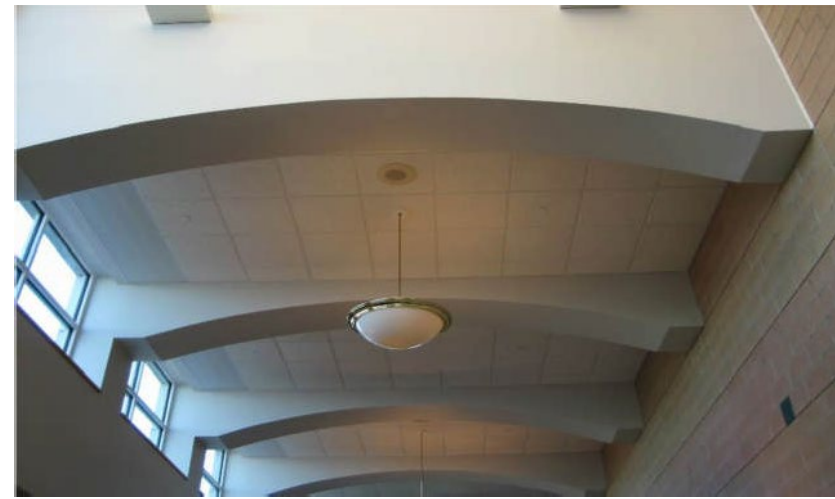
Health Education Building – Daylighting controls for the Atrium would save energy.
