Building Report | Life Sciences Façade & Addition

1.26.18

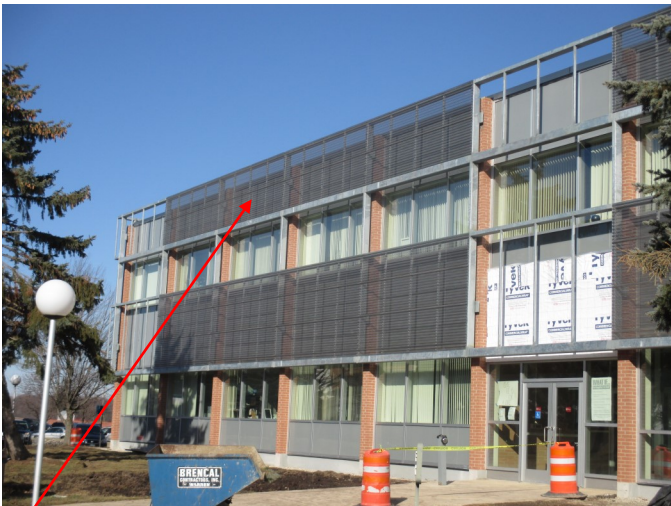
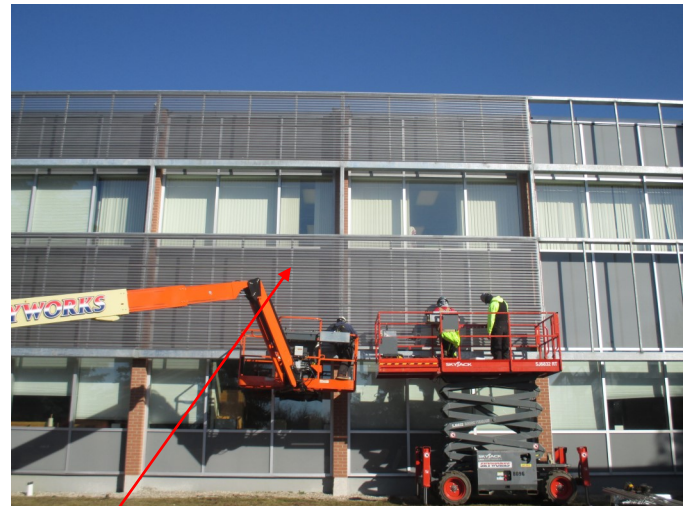
The top two photos show the progress of the installation of the new shade system on the south face of the existing building. These perforated and corrugated metal panels are just the vertical portion of the new shade system. After all of the vertical panels are installed the contractors will then install the horizontal portion. These panels match what is being installed on the north face of the existing building except for they are being installed on a completely vertical plane as opposed to a curved face like the other side. These same panels will wrap around and cover the southwest and southeast faces of the building.
